# SAMARCO – IMMEDIATE CAUSES TO THE FAILURE OF THE FUNDÃO DAM

SUMMARY OF CONCLUSIONS PRESENTED BY  
THE FUNDÃO TAILINGS DAM REVIEW PANEL

2016-10-12 / SVEMIN MILJÖKONFERENS / GÄLLIVARE  
SWECO GRUVDAMMAR OCH DEPONERINGSHANTERING

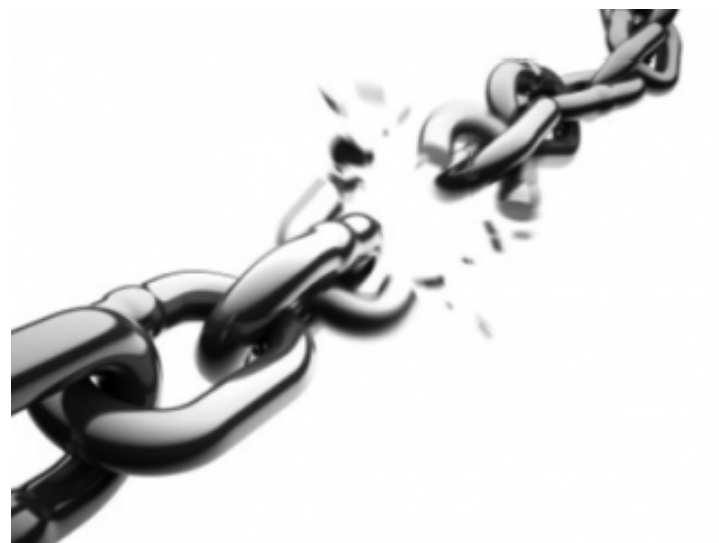
- The dam failure occurred because of a series of events and conditions that allowed the failure to take place

- a) Year 2009 - Damage to starter dam
- b) Year 2011,12 - Slime deposition issues
- c) Year 2012 - Shift of the dam crest alignment (the “set back”)

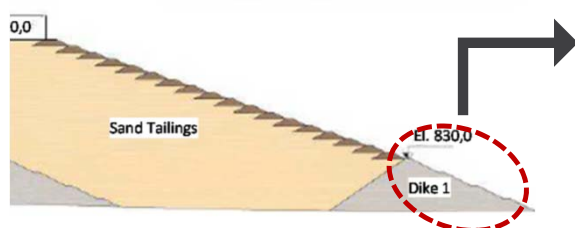
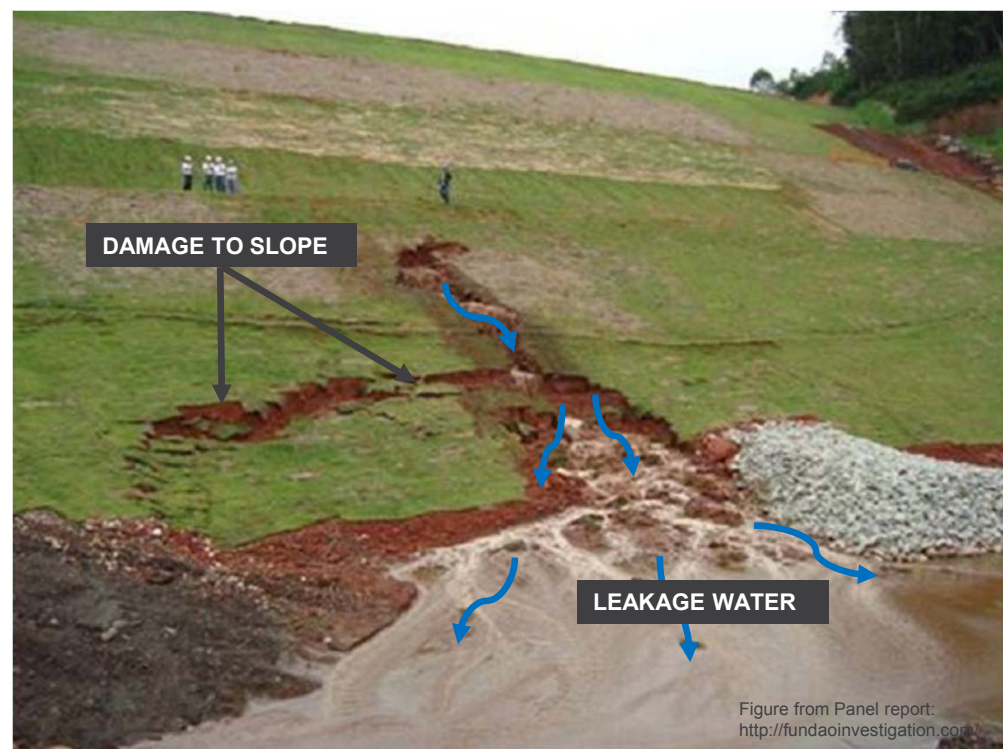
## Year 2009: Damage to the Start dam (Dike 1)

- April 2009, large seepage flows carrying tailings on the downstream slope.
- Seepage flows emerged above underdrain outlet level.

- Underdrains were sealed as they could not be repaired. → One of the most important element became inoperative
- A new blanket drain constructed on the surface of the tailings → The sand tailings below and upstream of the new blanket drain remained saturated

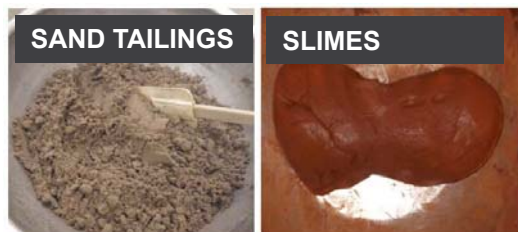
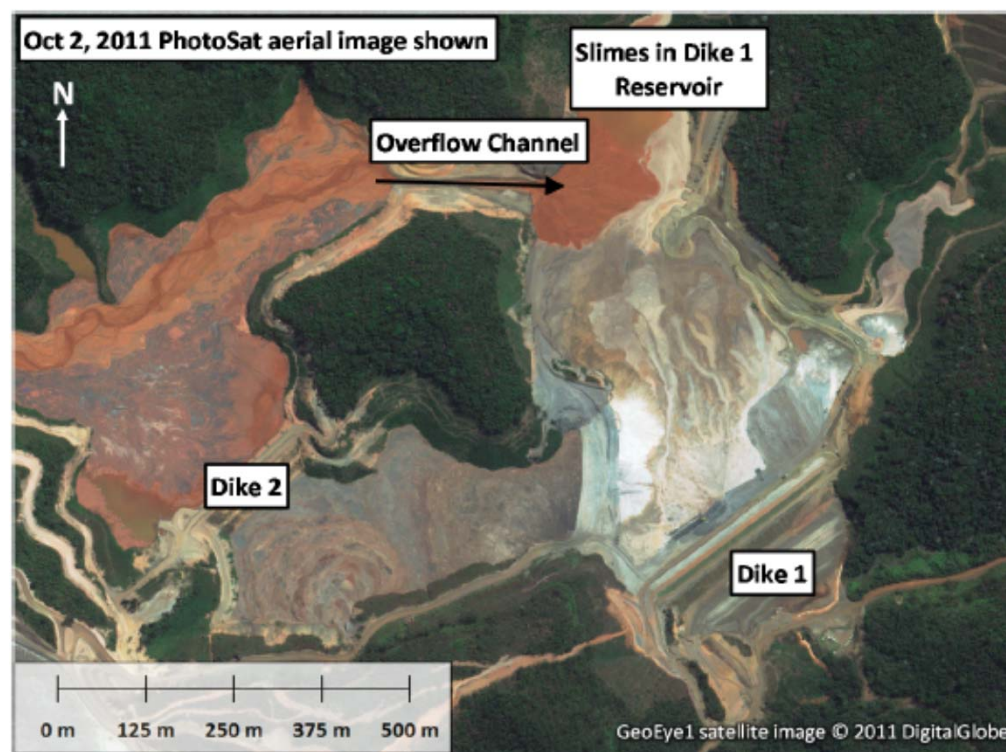
## Year 2011/12 – Slime deposition issues

- During 2011 and 2012 slime was rerouted through an overflow channel into the Fundao reservoir.
- The original and revised design specified a minimum 200 m wide beach of sand tailings to control saturation.

- Deposition of slimes in areas where this was not intended in design
  - At times beach only 60 m wide.
  - Slimes near the downstream slope and below the raised dam construction.

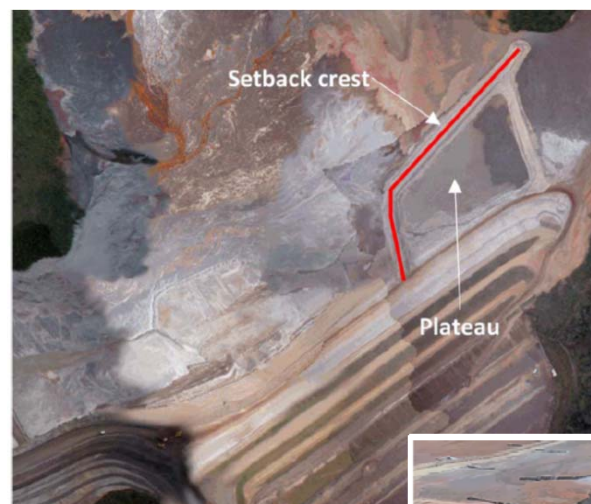
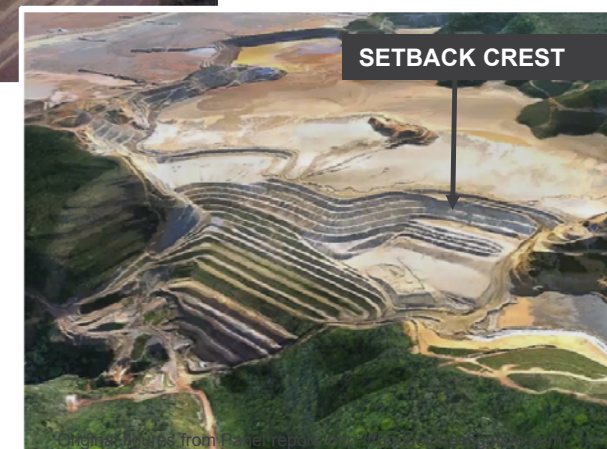
## Year 2012: The left abutment “Set back”

- In October 2012 the dam alignment (crest) was moved upstream from its original design, called the “setback crest”.
- The change due to structural integrity issues of a abutment concrete gallery, that drained left abutment run-off water.

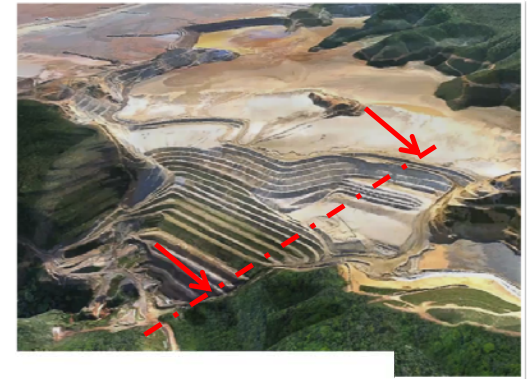
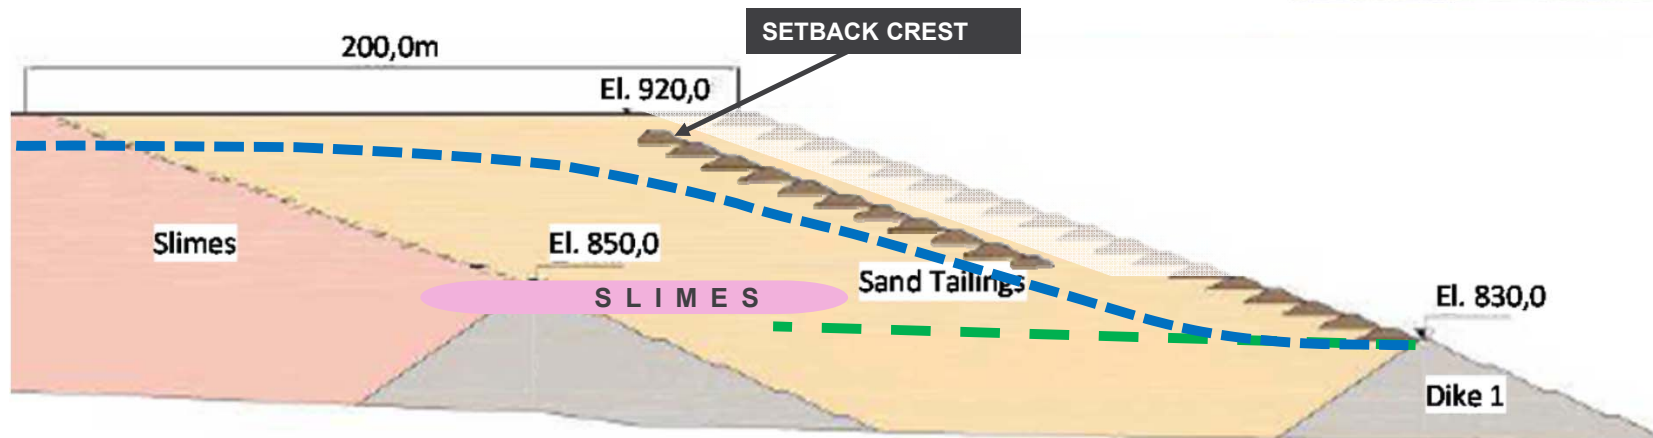
- The setback had significant effects. Moving the embankment back, toward the impoundment, caused it to be raised over the slimes deposited in 2011 and 2012.

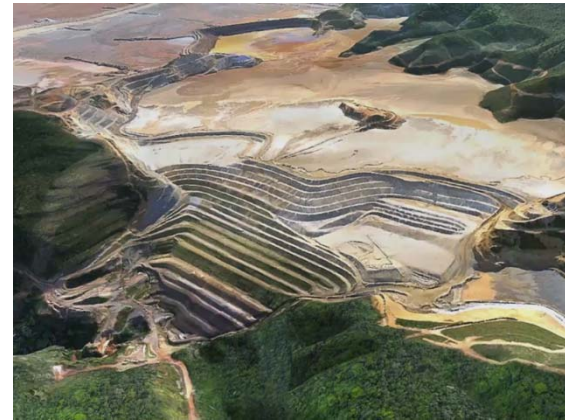
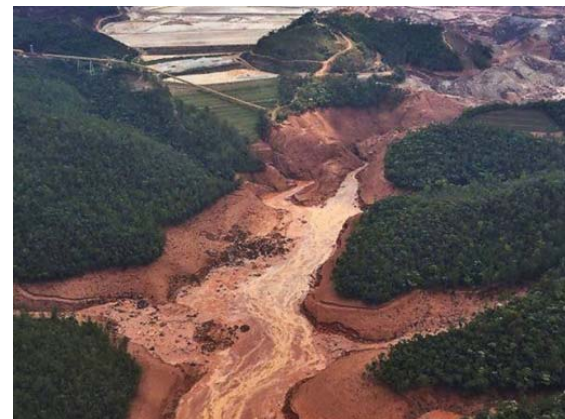
Contractive (loose) material

Saturation

Trigger mechanism – liquefaction by lateral extrusion [[Movie clip 2.5 min, start at 2:53](#)]
