# SAMARCO – IMMEDIATE CAUSES TO THE FAILURE OF THE FUNDÃO DAM

SUMMARY OF CONCLUSIONS PRESENTED BY  
THE FUNDÃO TAILINGS DAM REVIEW PANEL

2016-10-12 / SVEMIN MILJÖKONFERENS / GÄLLIVARE  
SWECO GRUVDAMMAR OCH DEPONERINGSHANTERING

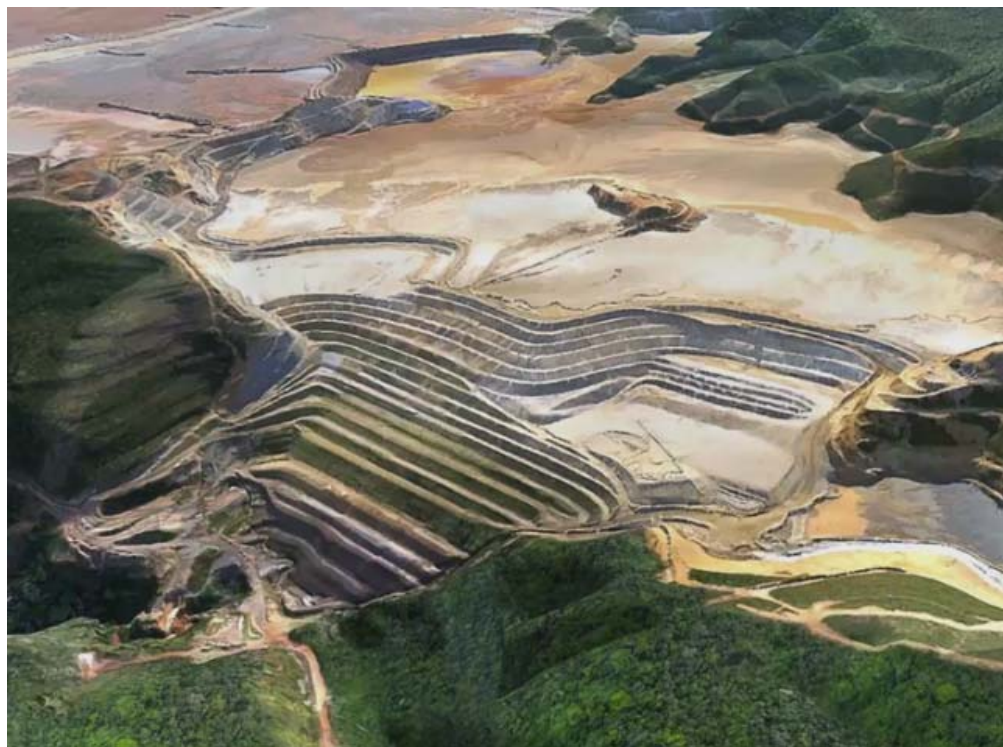
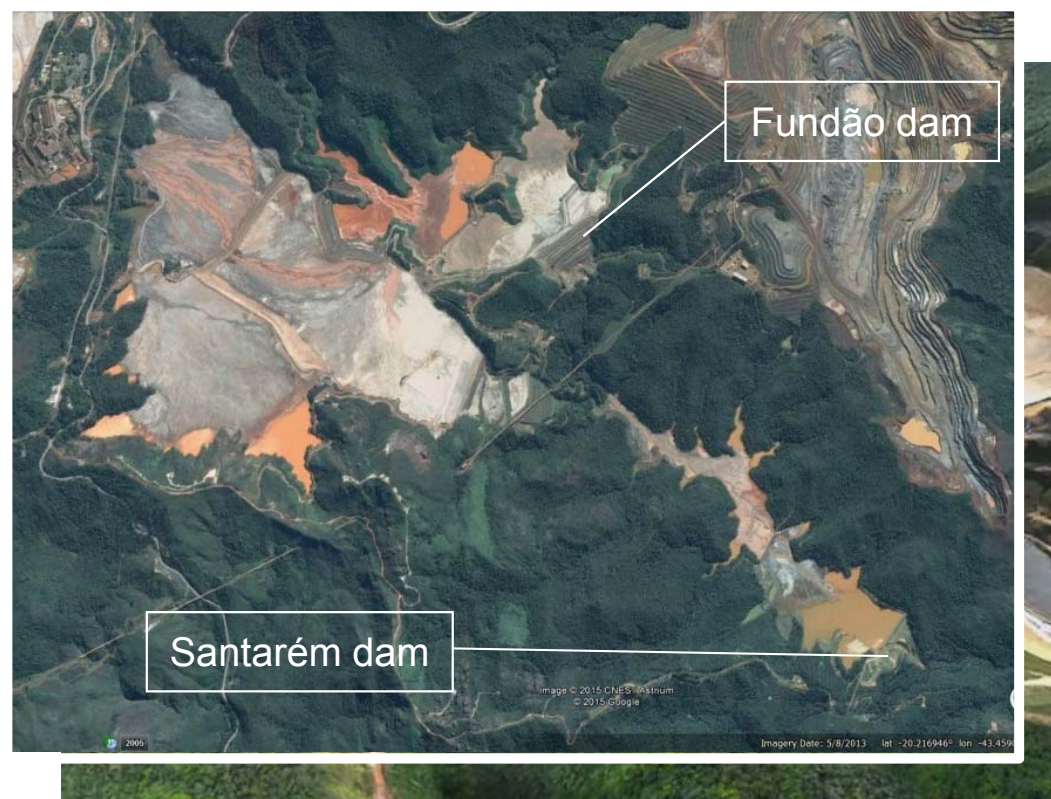
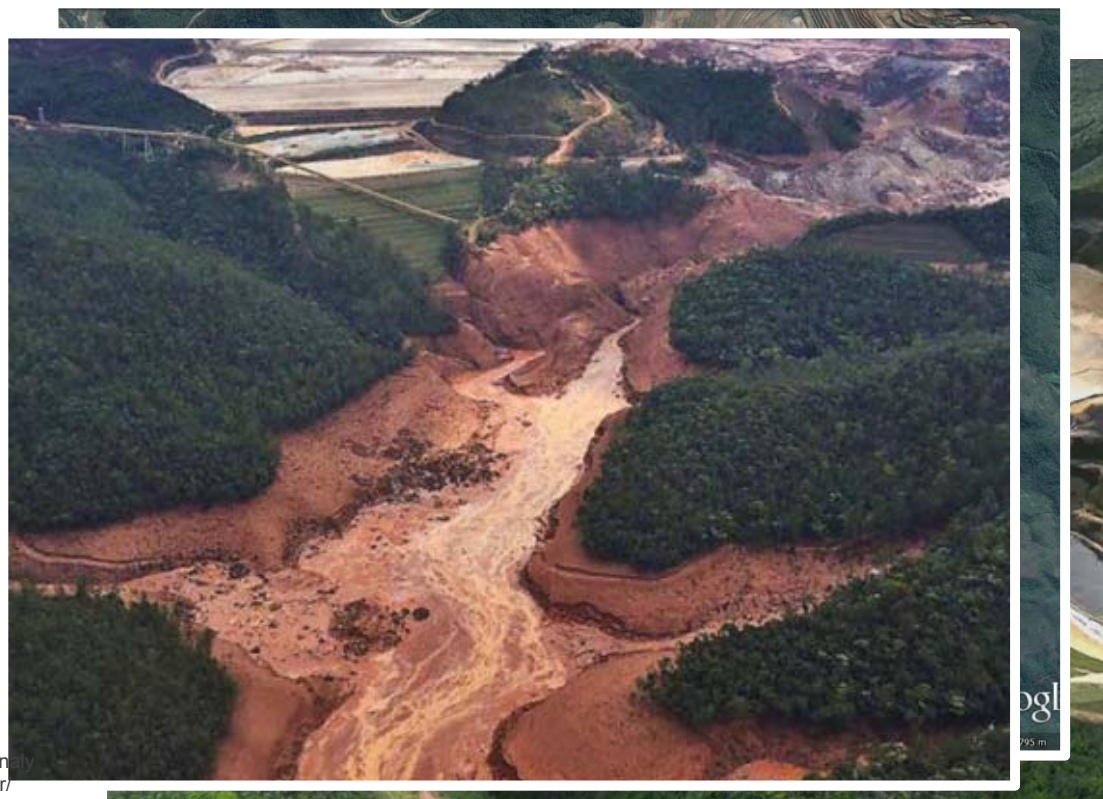
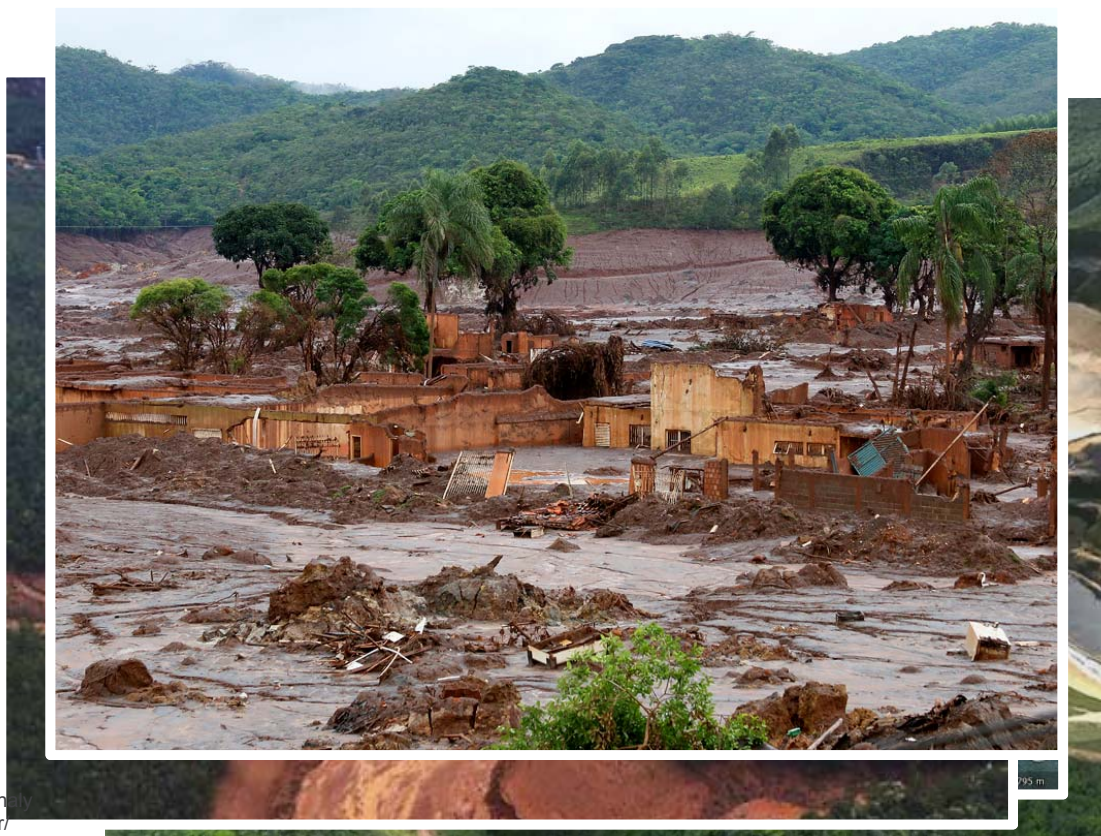
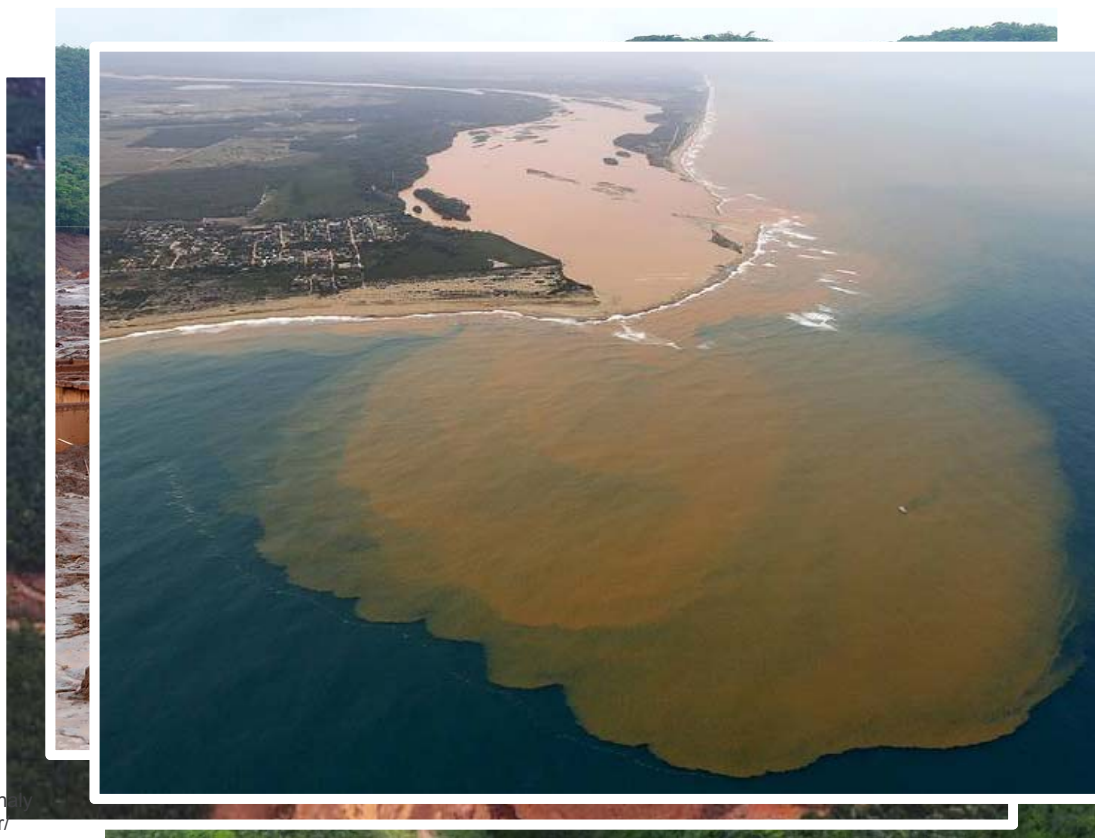
- In 2015 on November 5 the 110 m high Fundão Tailings Dam failed in a liquefaction flowslide.
- More than 60 Mm<sup>3</sup> of tailings and water spread as a mud flow in the river system along its 650 km path to the Atlantic Ocean.
- In total 18 people lost their lives.
- The owner Samarco Mineração S.A. (BHP Billiton Brazil Ltda, Vale S.A.) initiated The Fundão Tailings Dam investigation to determine its cause

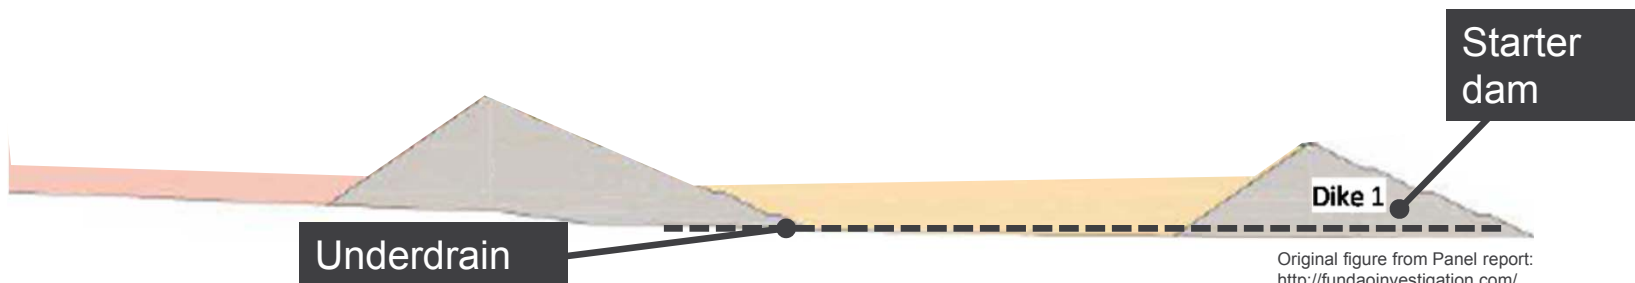
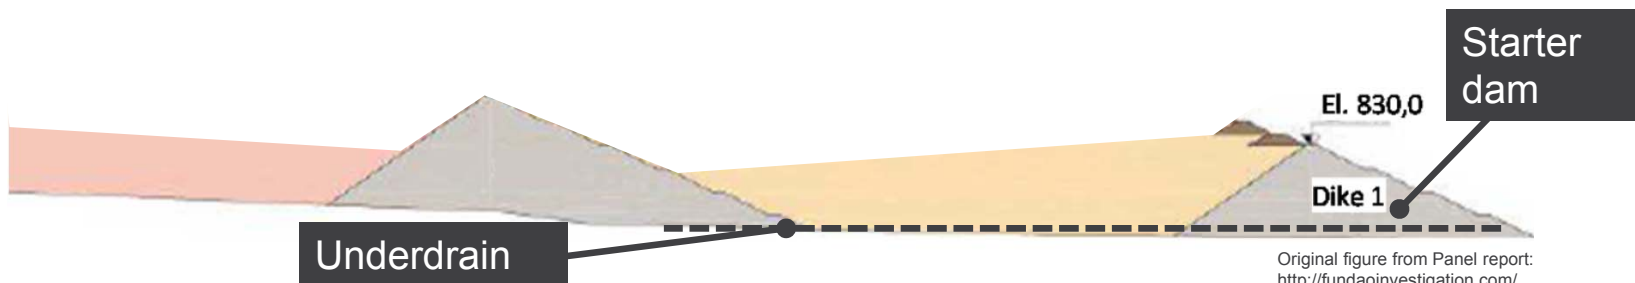
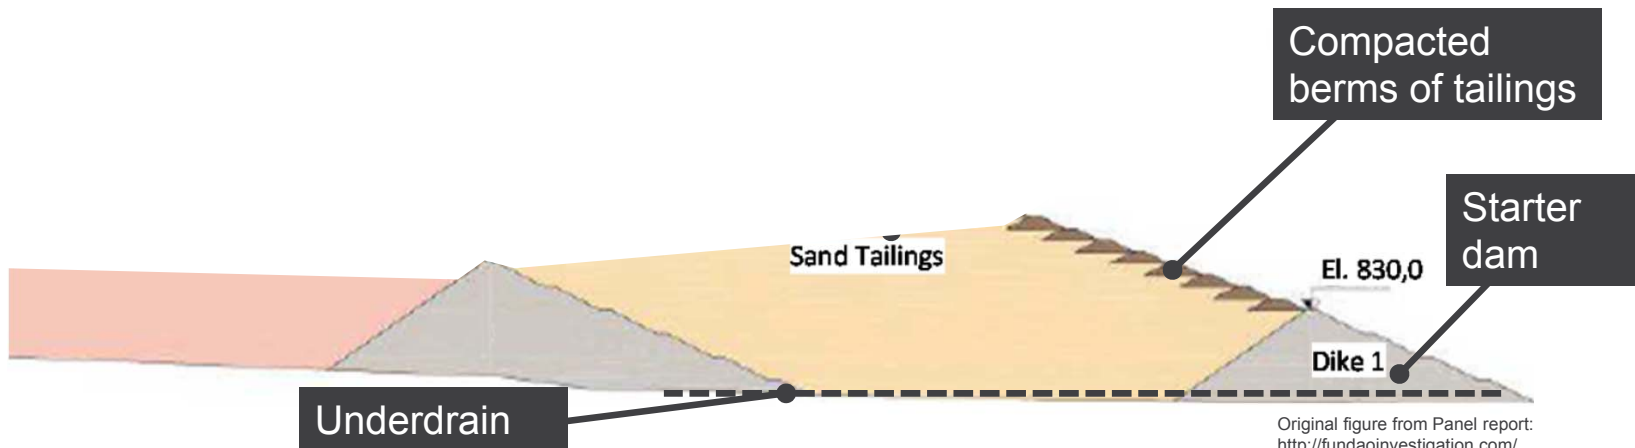
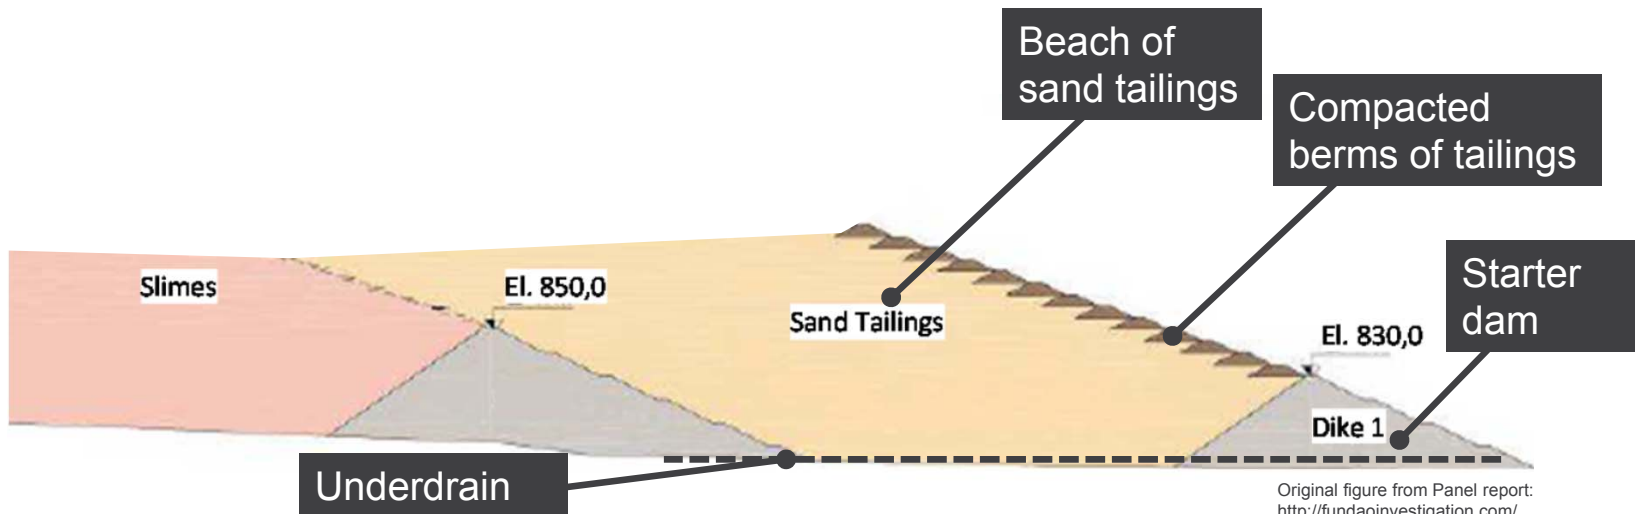
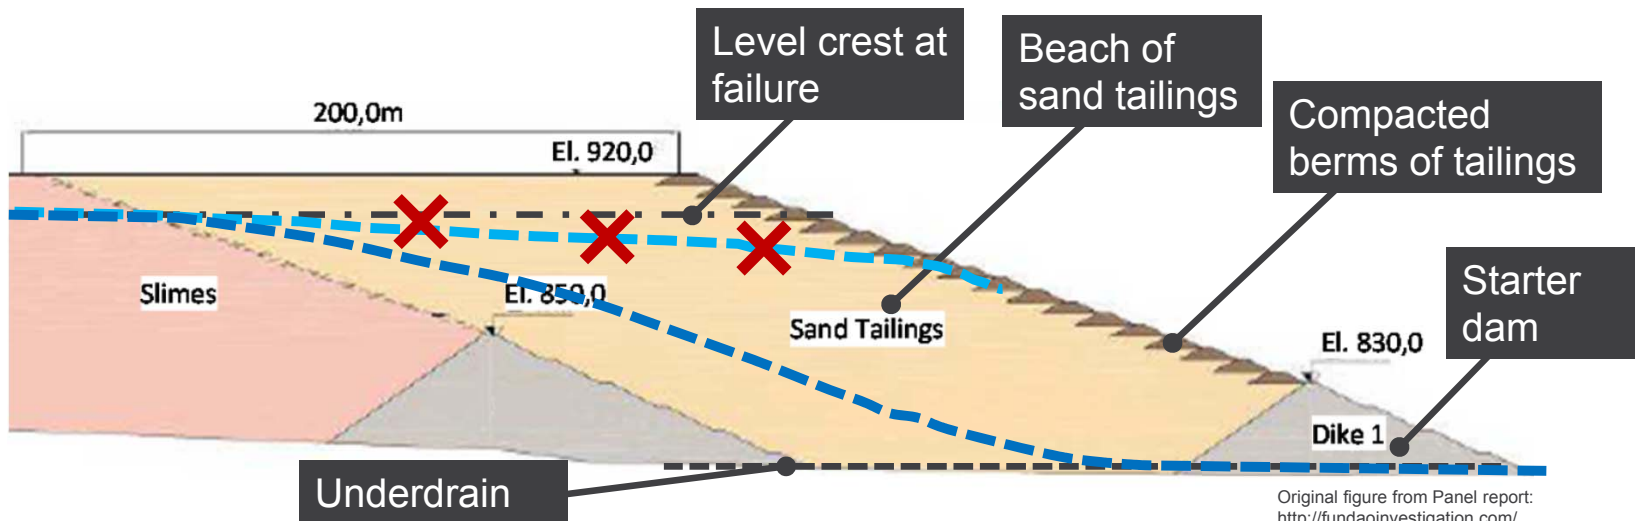
- **Start of construction:** 2007
- **Dam type:** Upstream raised tailings dam
- **Dam height at failure:** 110 m (EL +900 m)

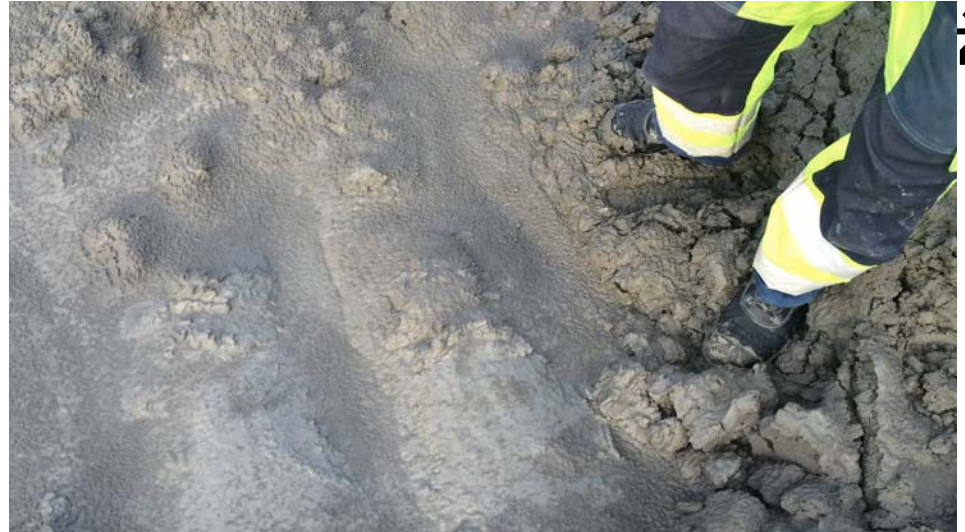
- Conditions required:
  - **Contractive material** > volume decreases during shearing because the particles move together.
  - **Saturation** > all voids are filled with water. If shearing occurs in a saturated contractive tailings excessive pore pressure may generate.
  - **Trigger mechanism, rate of loading vs. drainage capacity** > if the loading (shearing) is large enough or repeated many times the pore pressure in the voids may increase to such extent that friction between the grains is lost.

Saturated soft sand.  
Strength maintained because friction from the grains touching.

Saturated soft sand.  
High pore water pressure may break the friction between the grains causing liquefaction.
