Tailings Overview

Harvey McLeod

October 2013

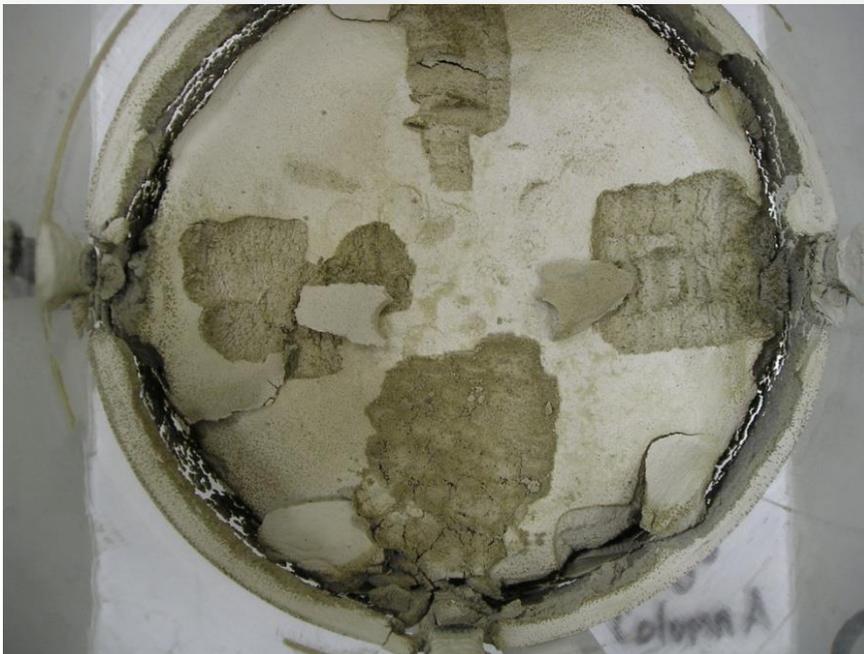
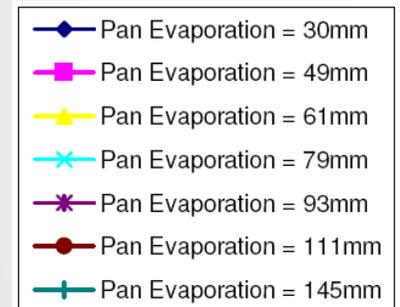
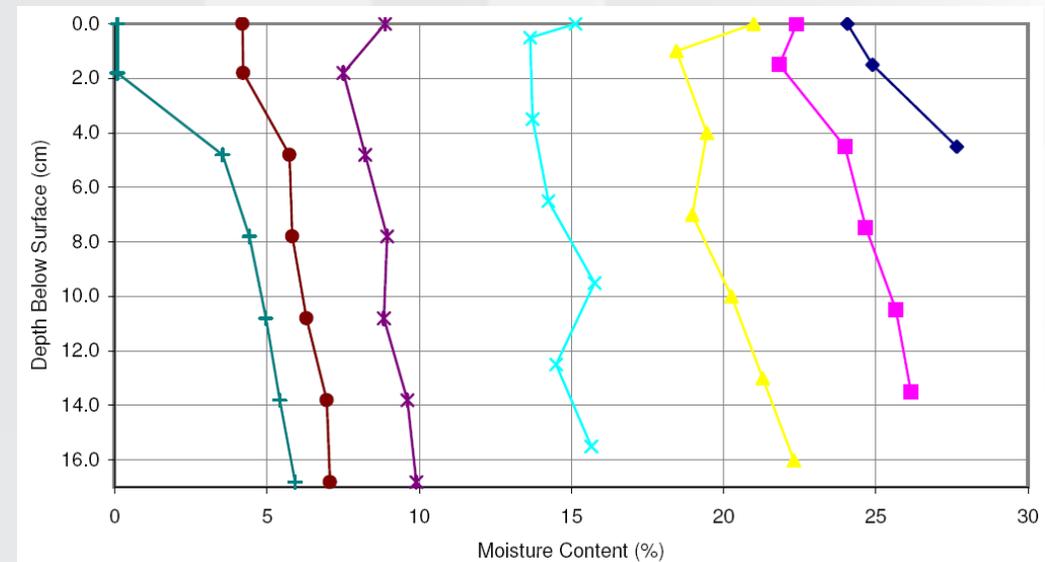
Evaporation Cell Tests

- Evaporation of ~ 40 mm (4 days in summer) results in desaturation at surface at ~ 80% solids
- A crust was formed on the surface, due to clays (8%) or precipitates (TDS ~ 300 mg/L)

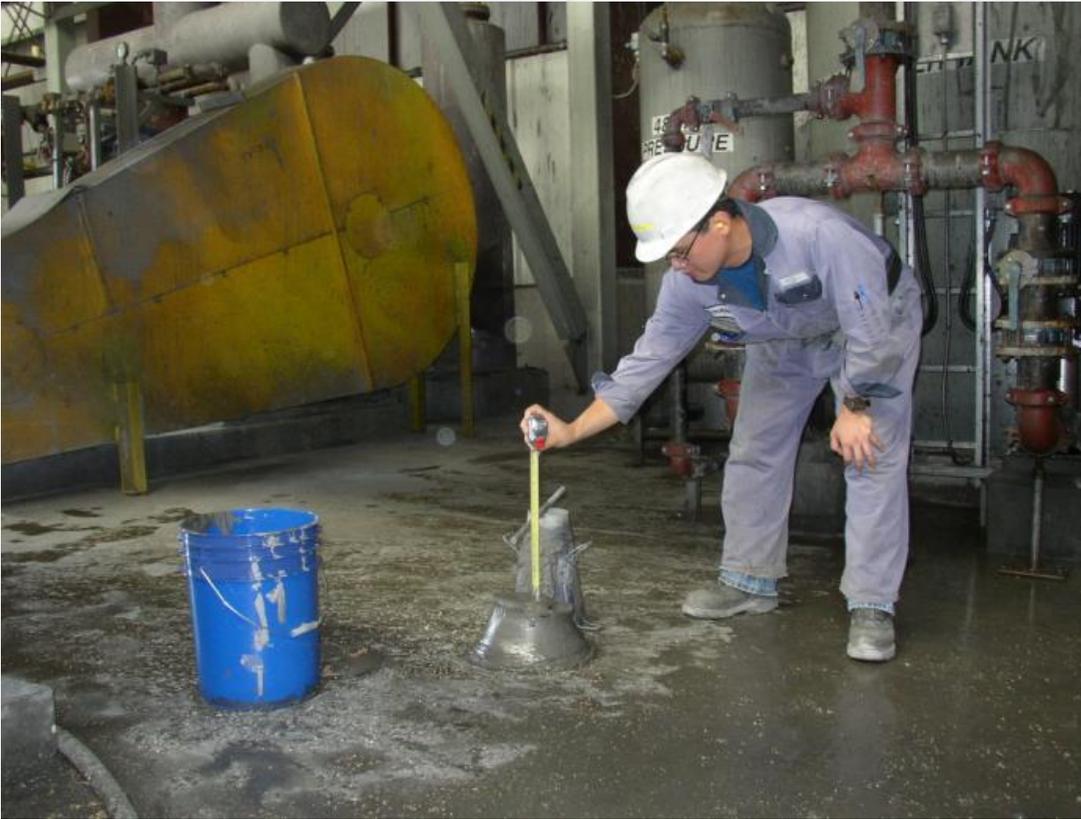
6.5 inch slump test and tailings densities

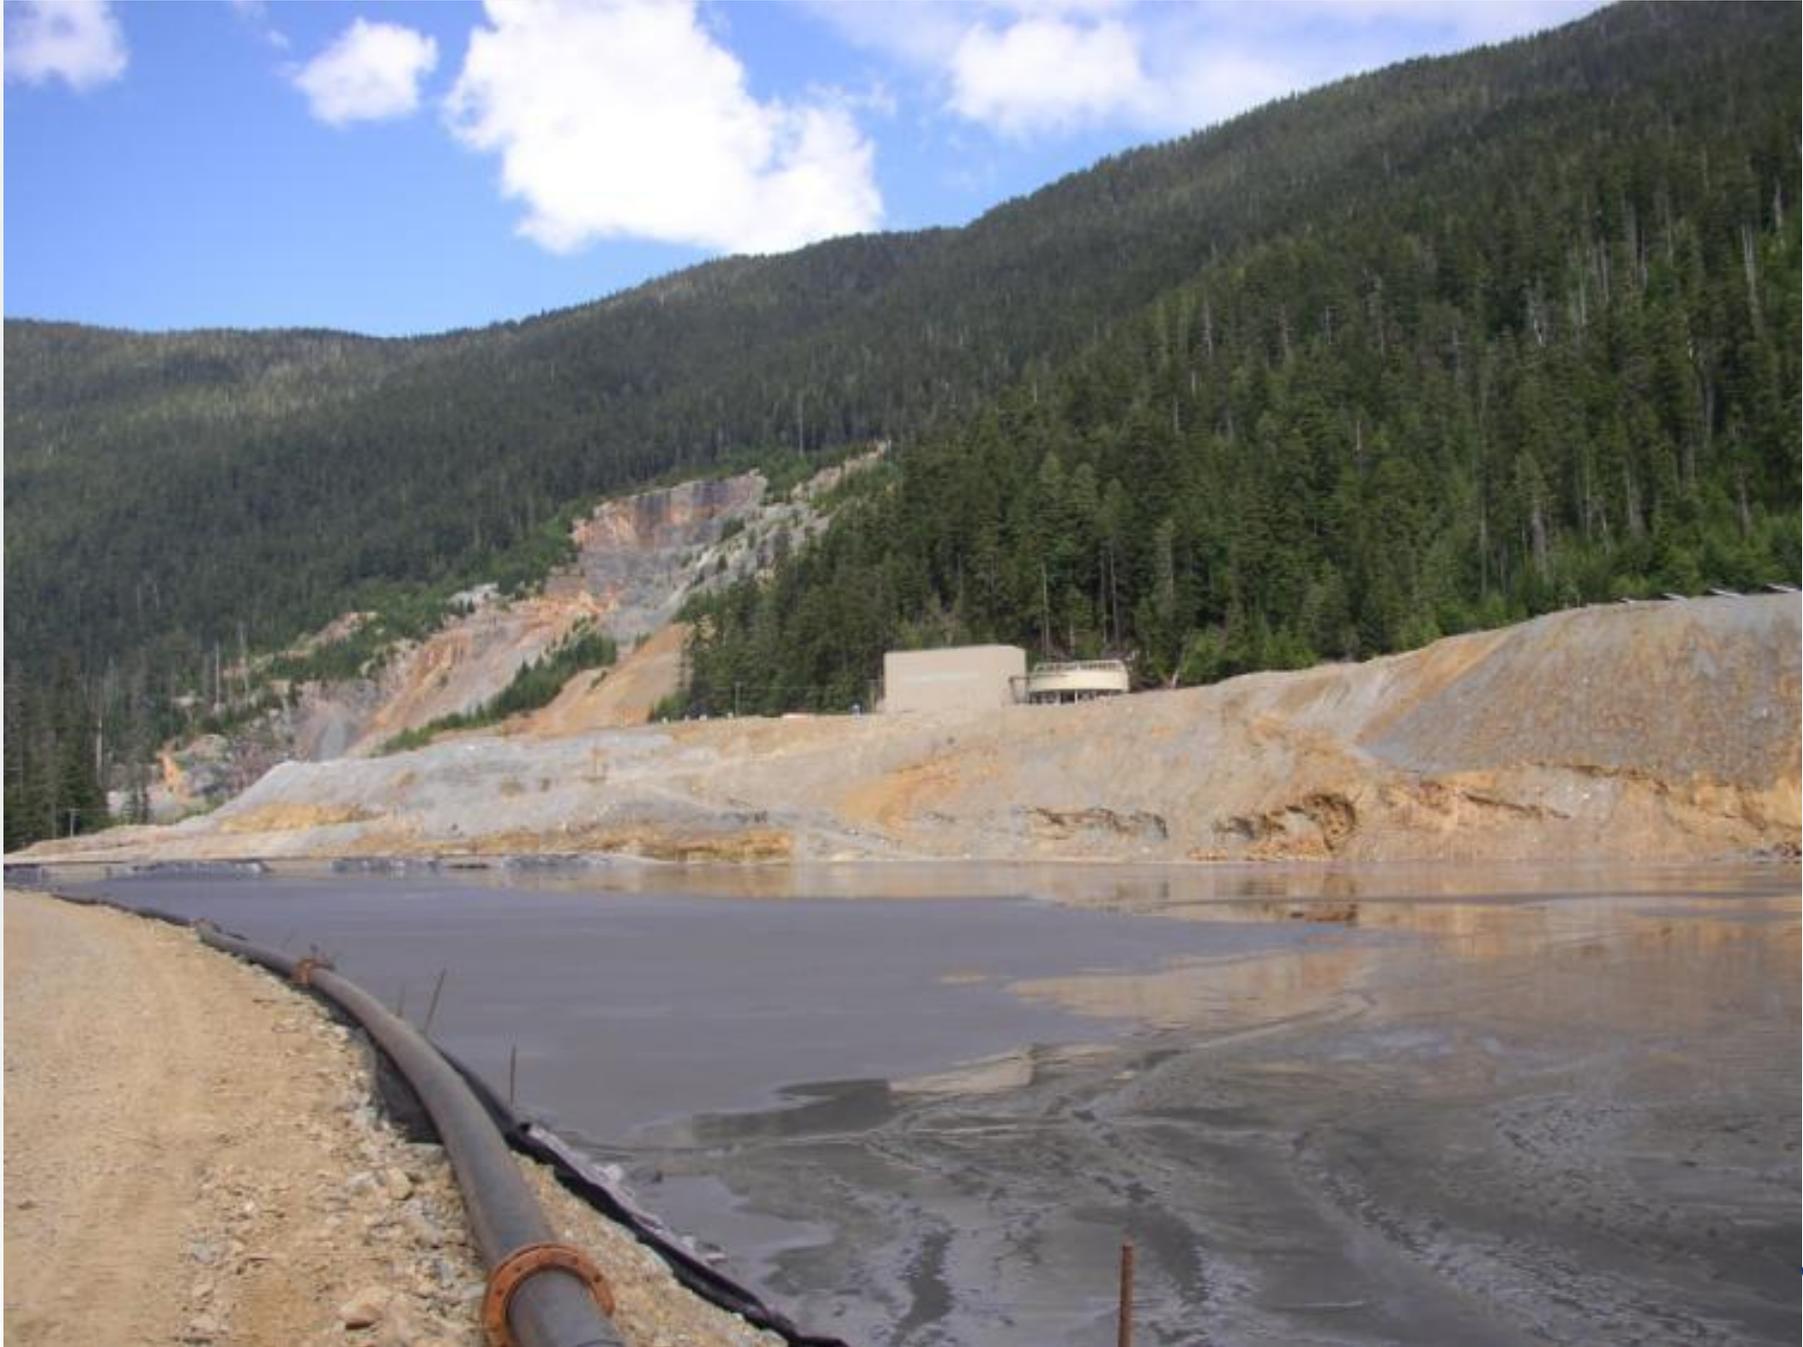
Myra Falls Paste Plant

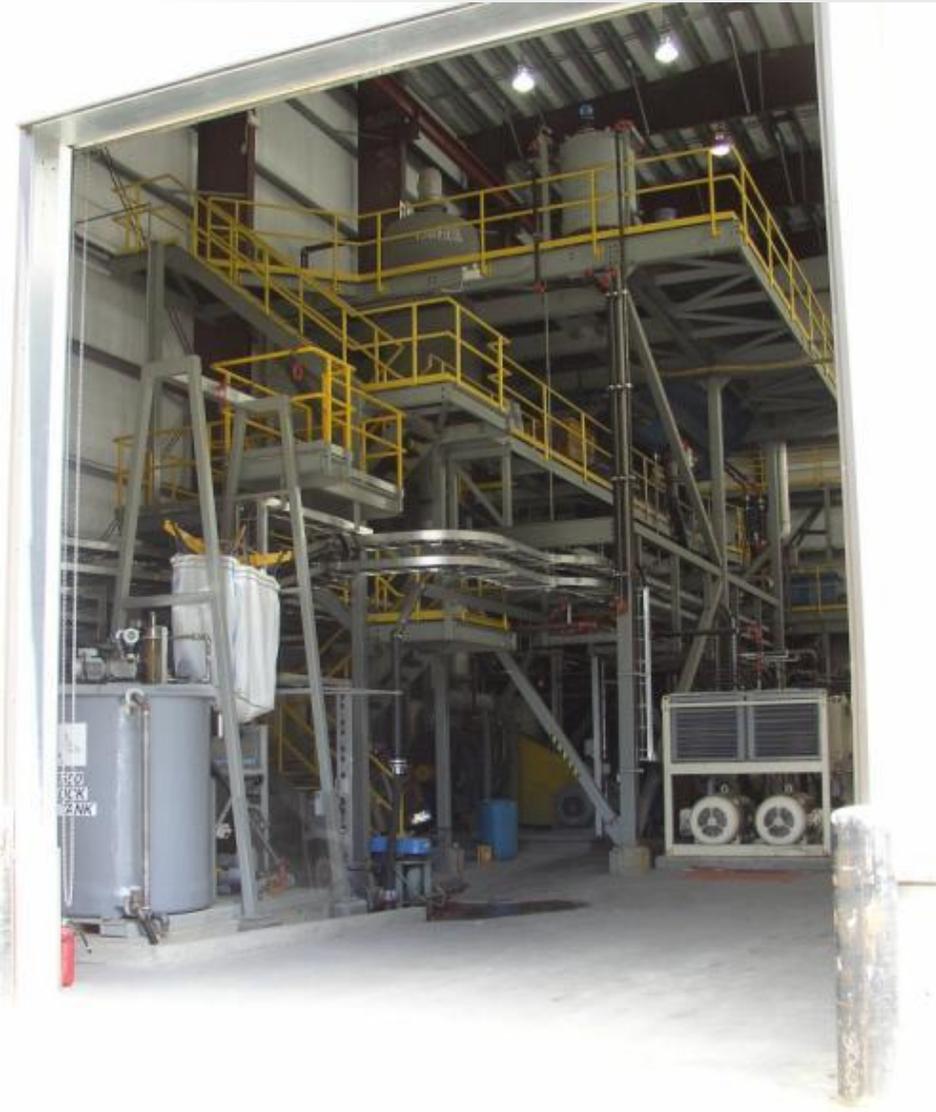
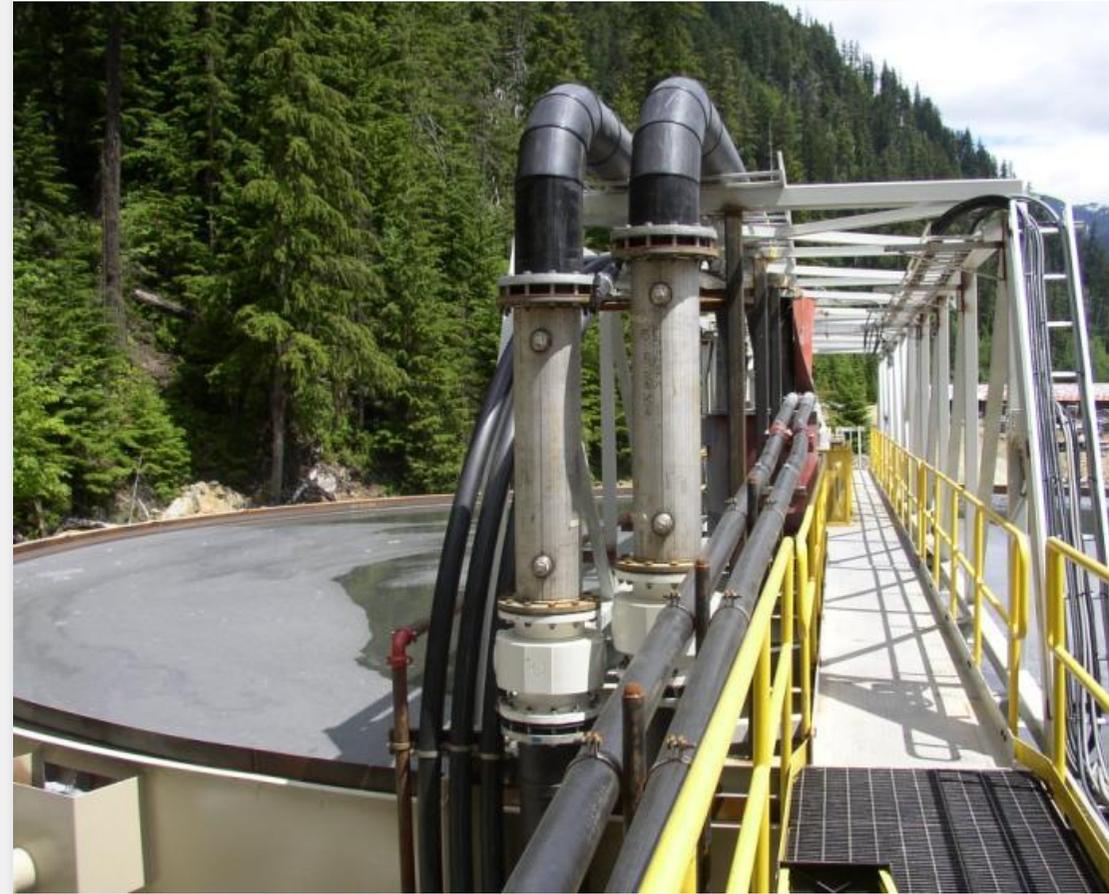
Paste Plant and Superflow Thickener

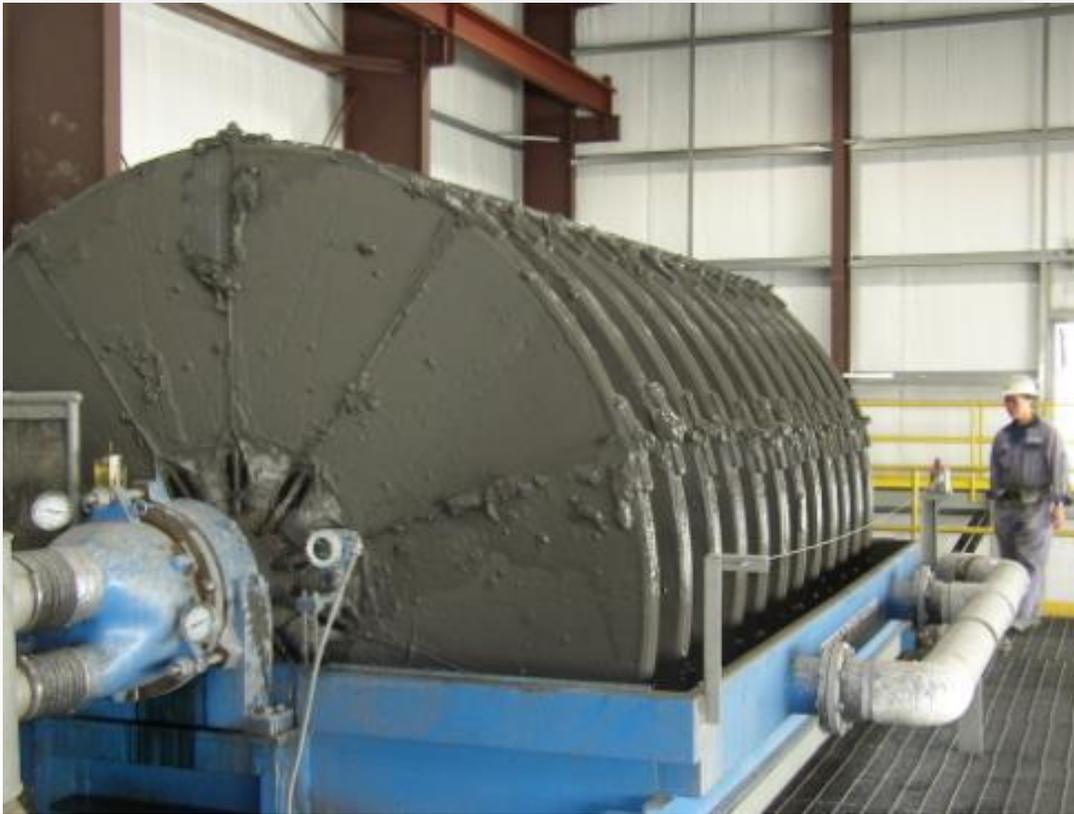
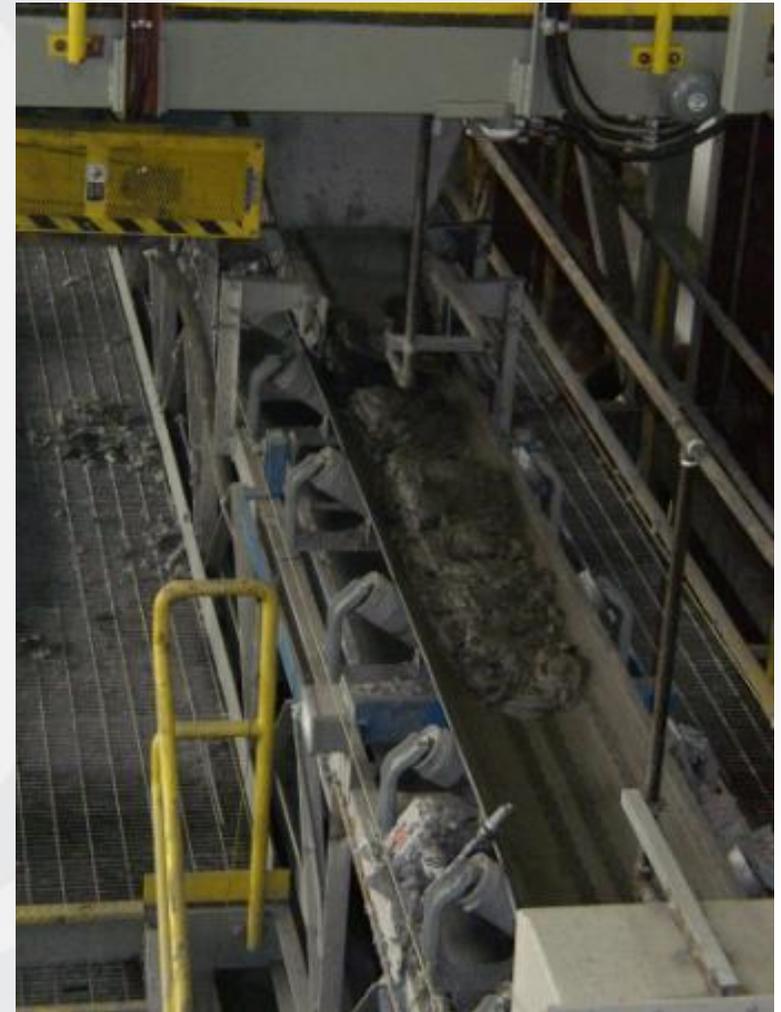
Vacuum filter and filtered tailings

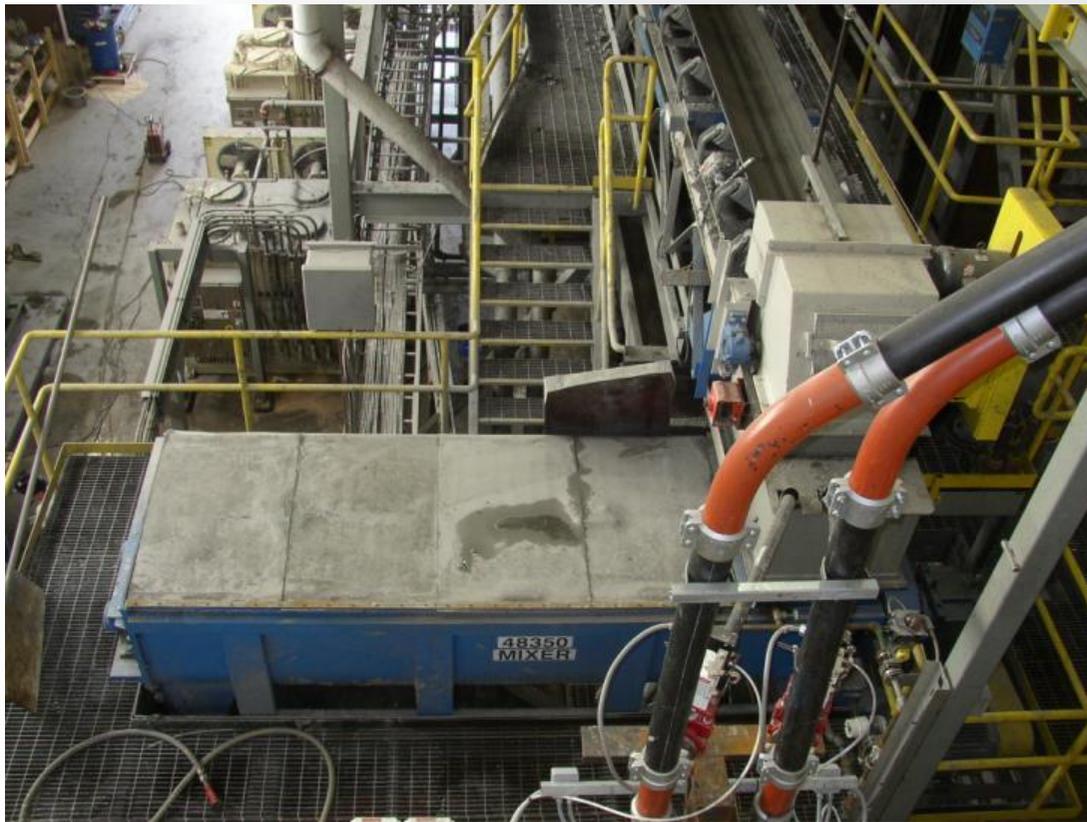
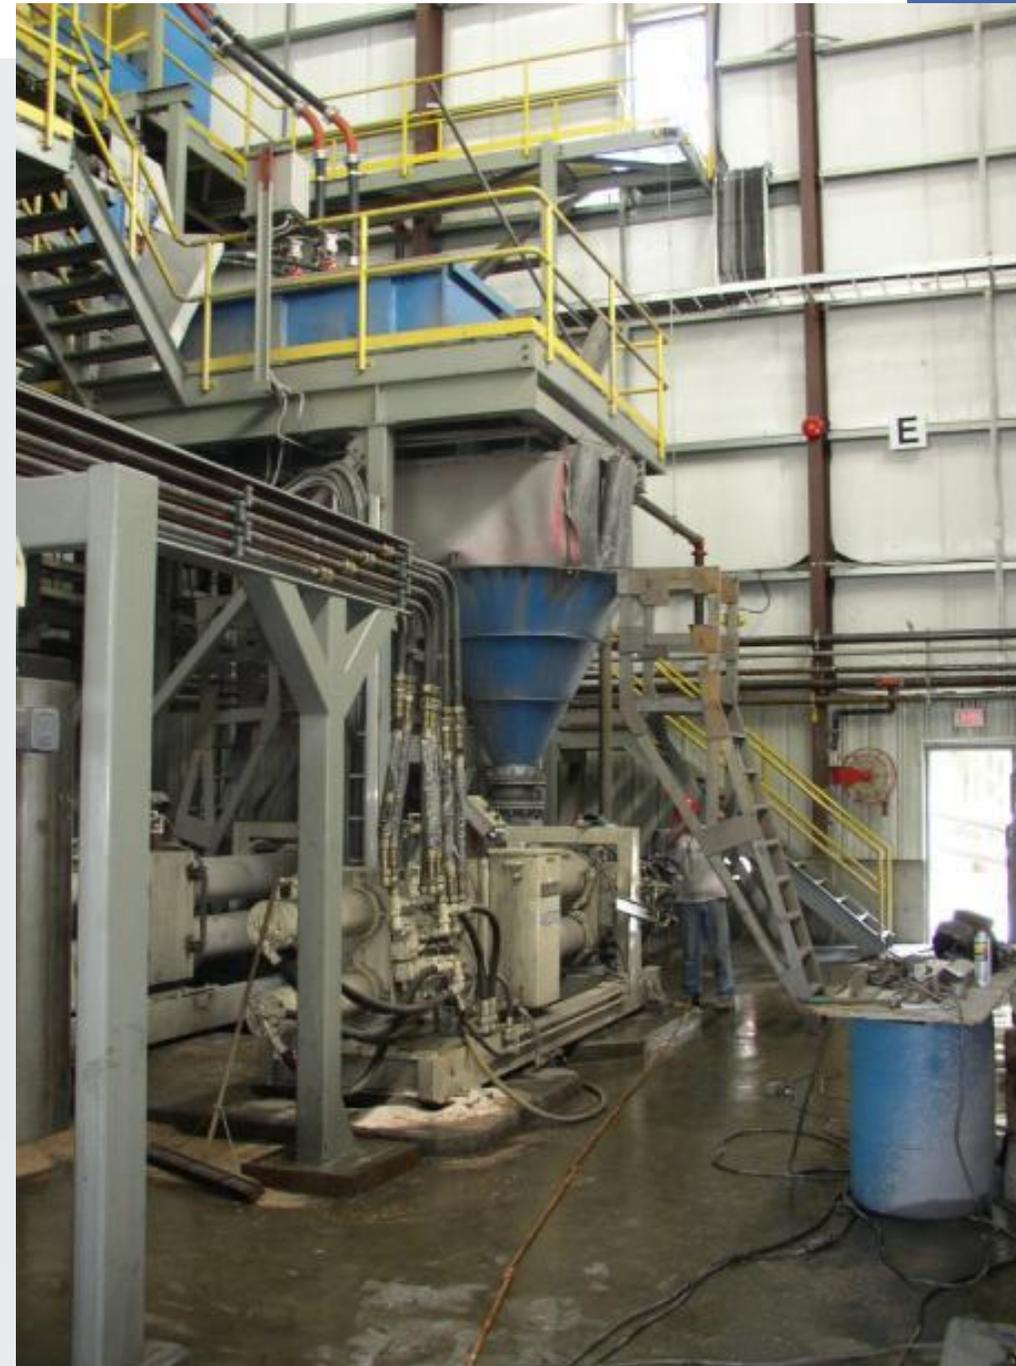
Paste tailings mixing unit

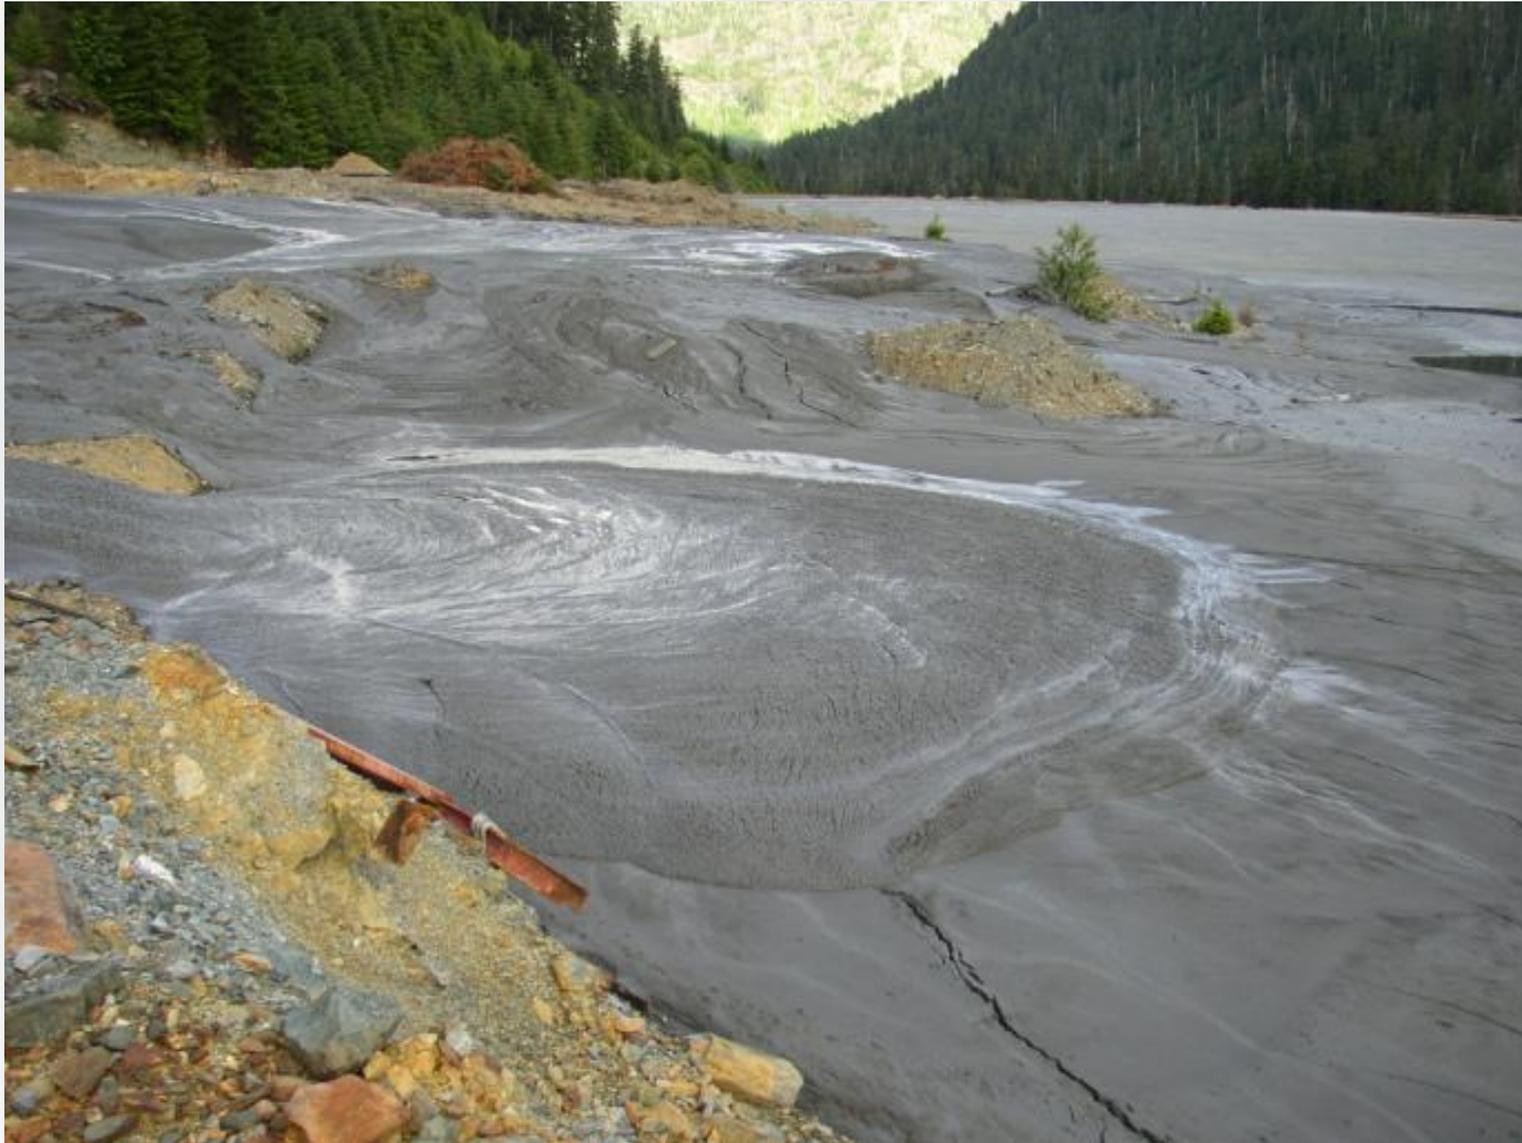
Consolidation bleed from paste tailings & 5% cone

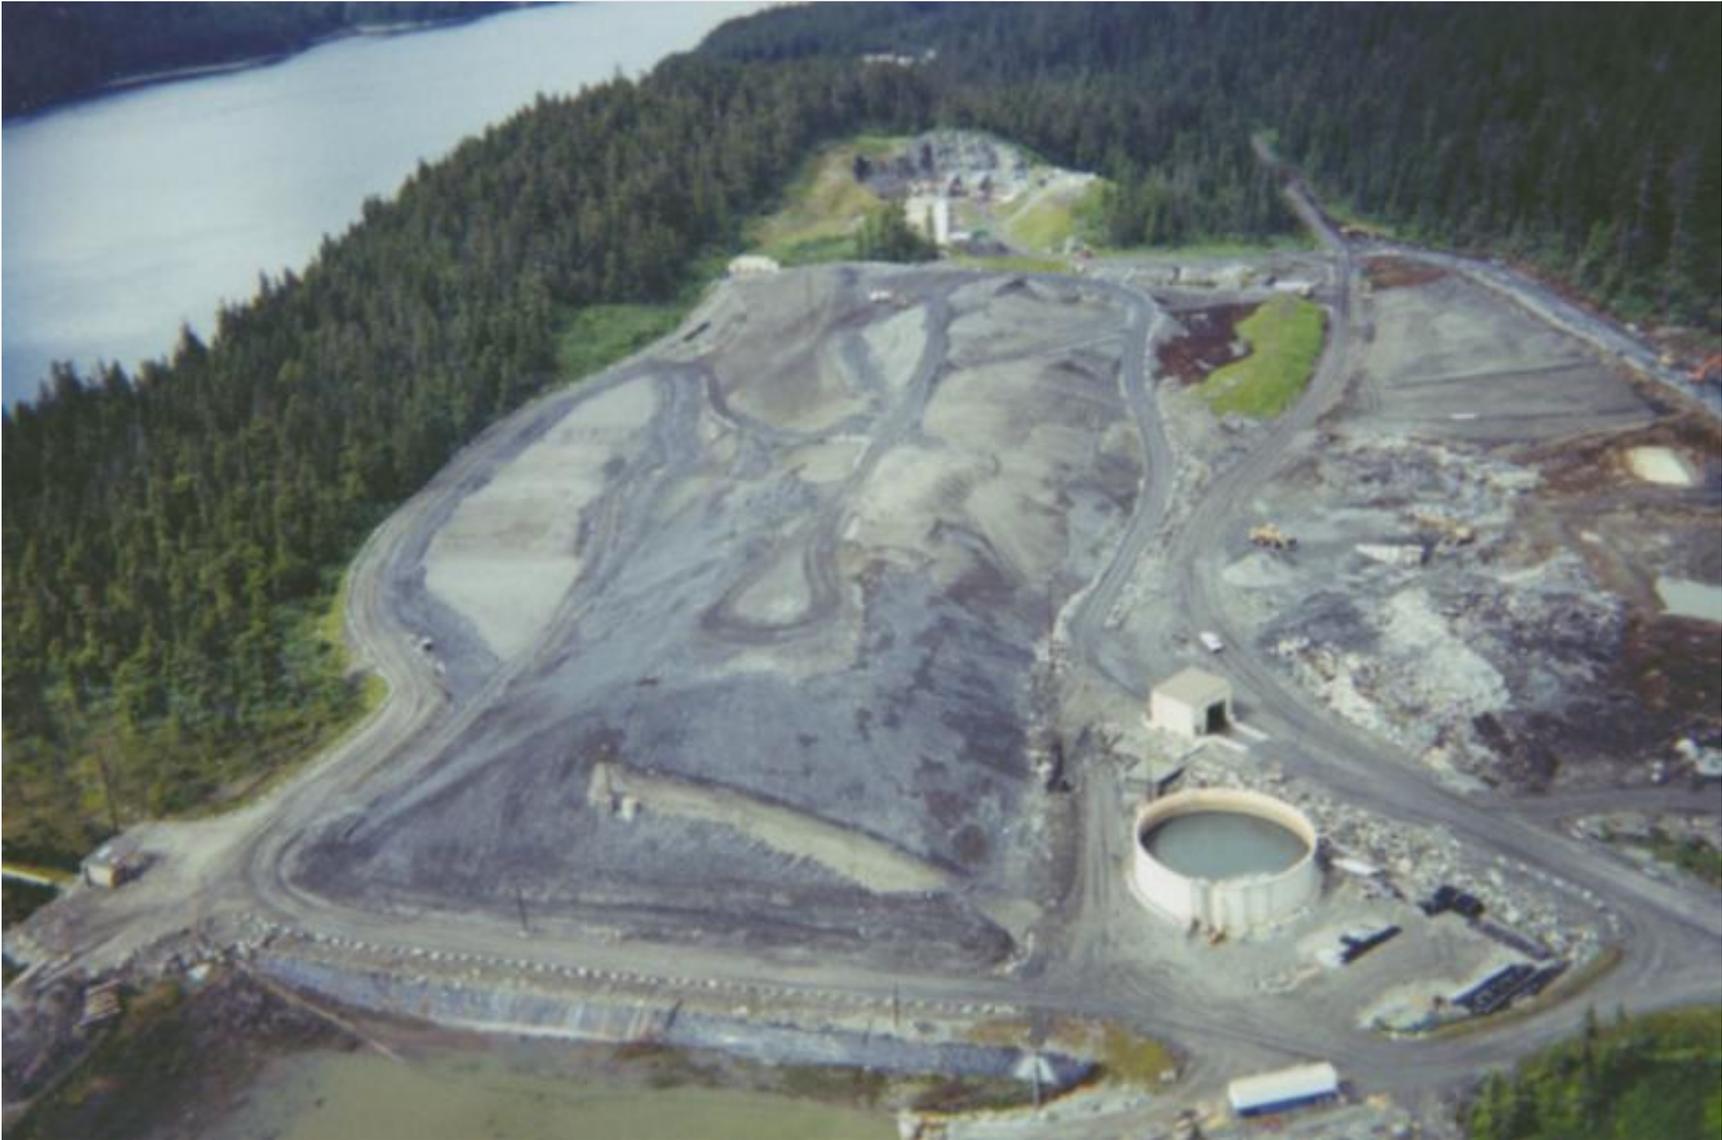
Greens Creek Filtered Tailings Disposal Site

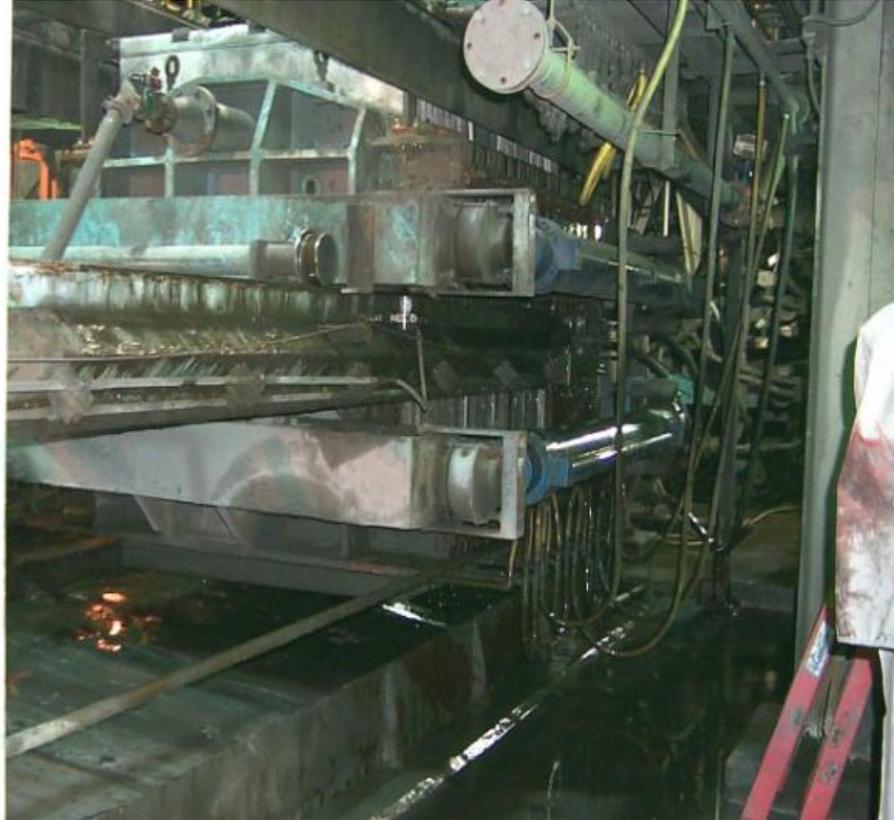
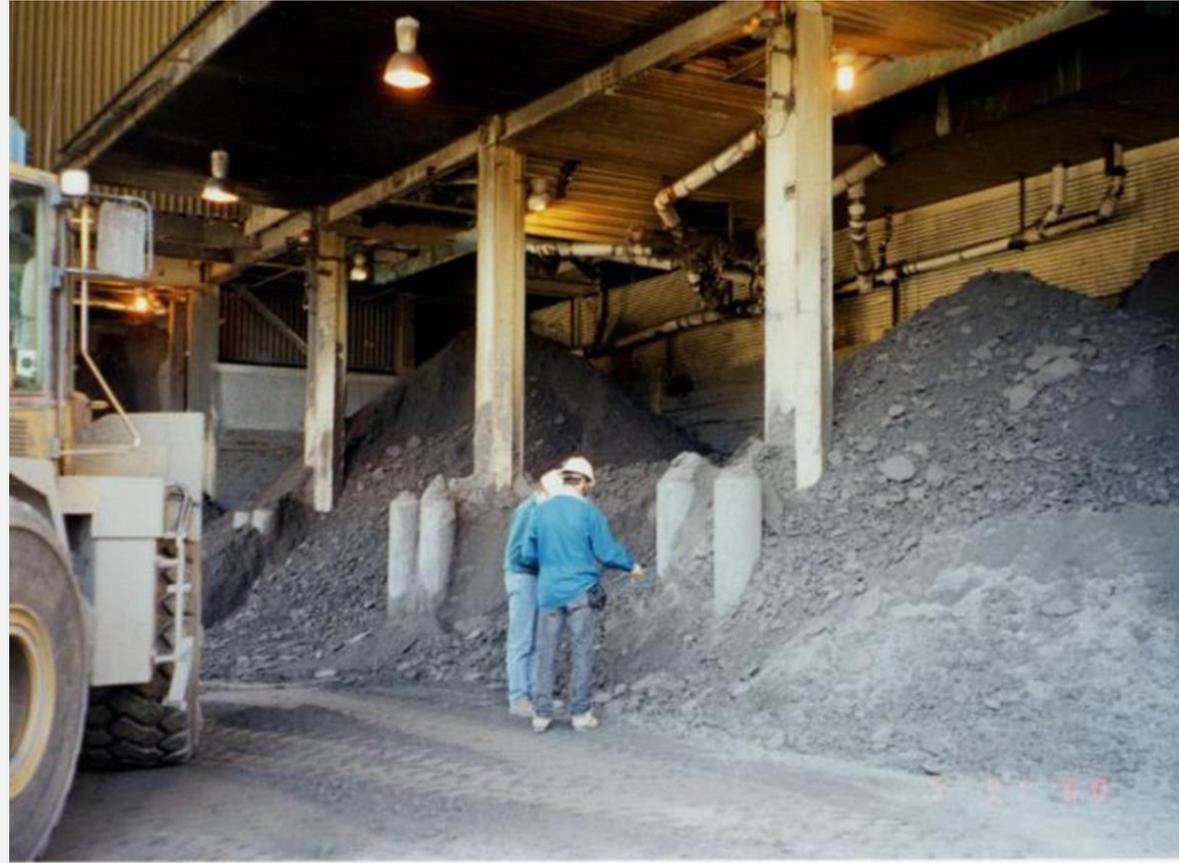
Tailings de-watered at mill using pressure filters

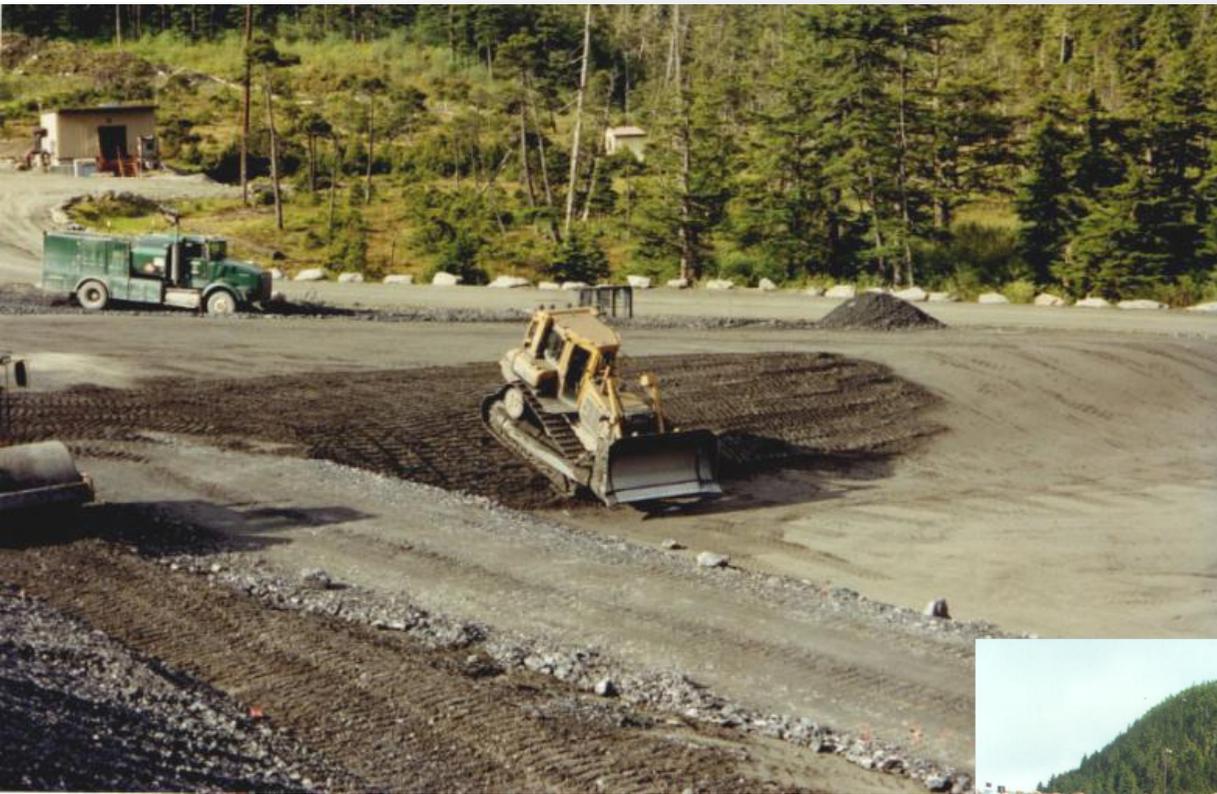
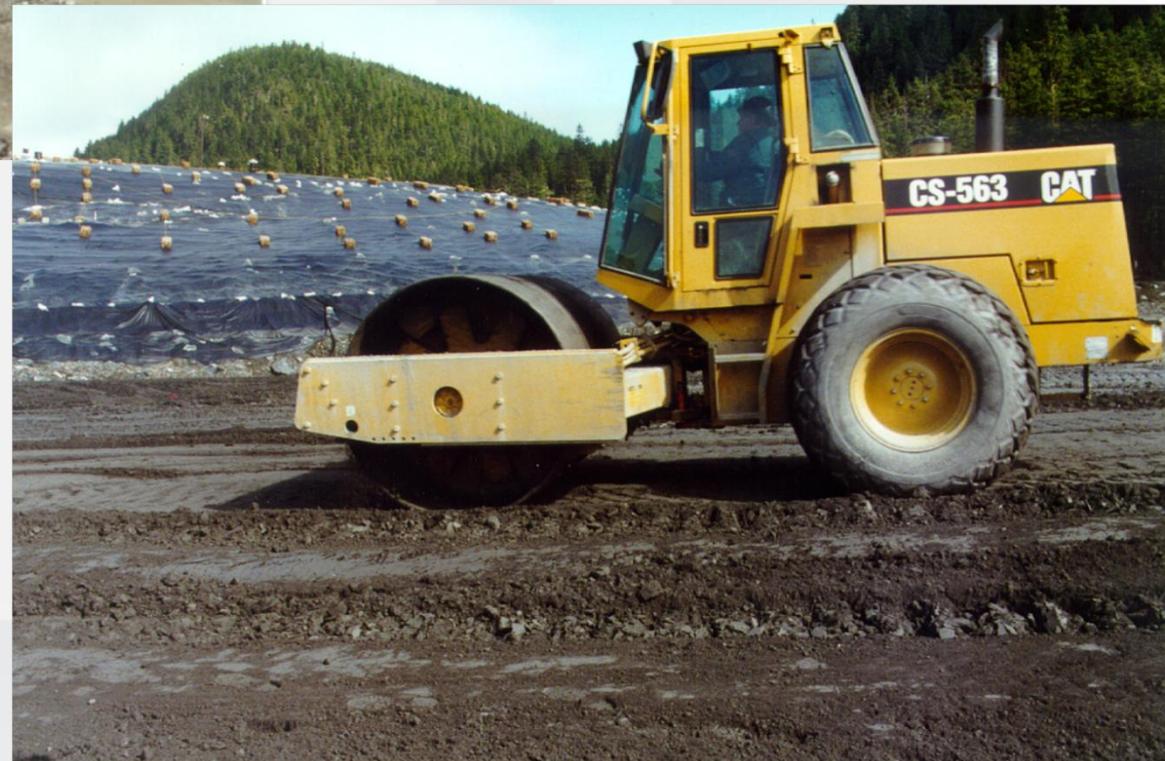
Placement and spreading of tailings with a dozer

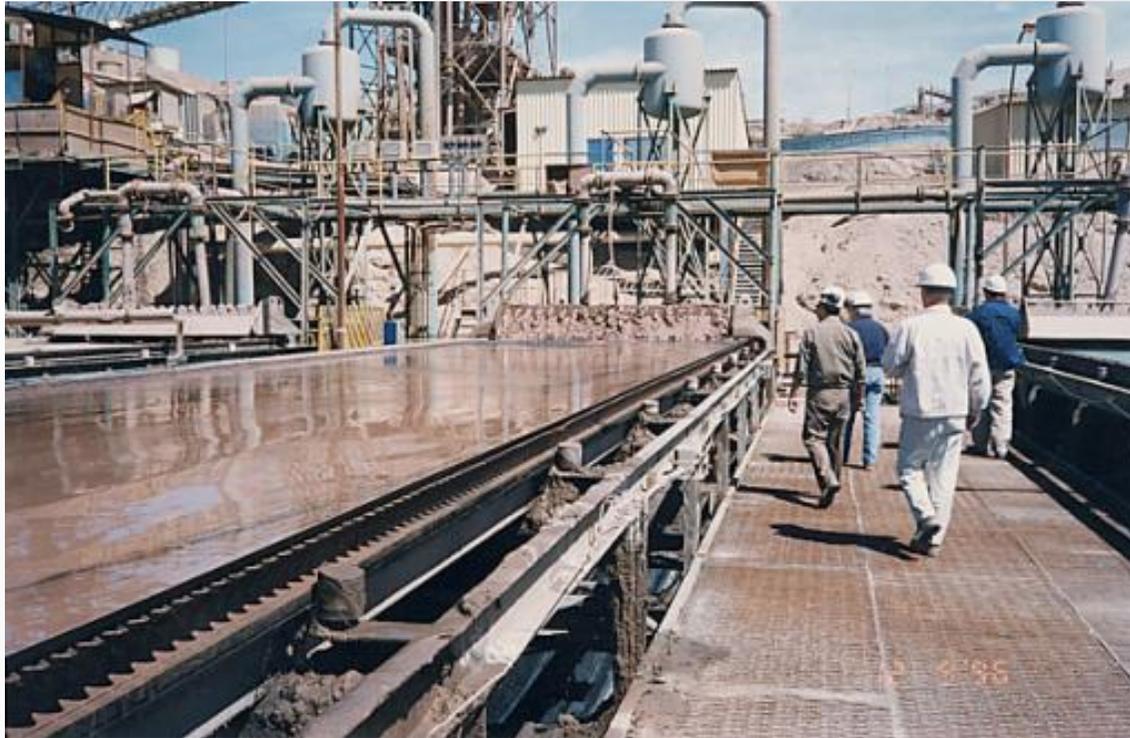
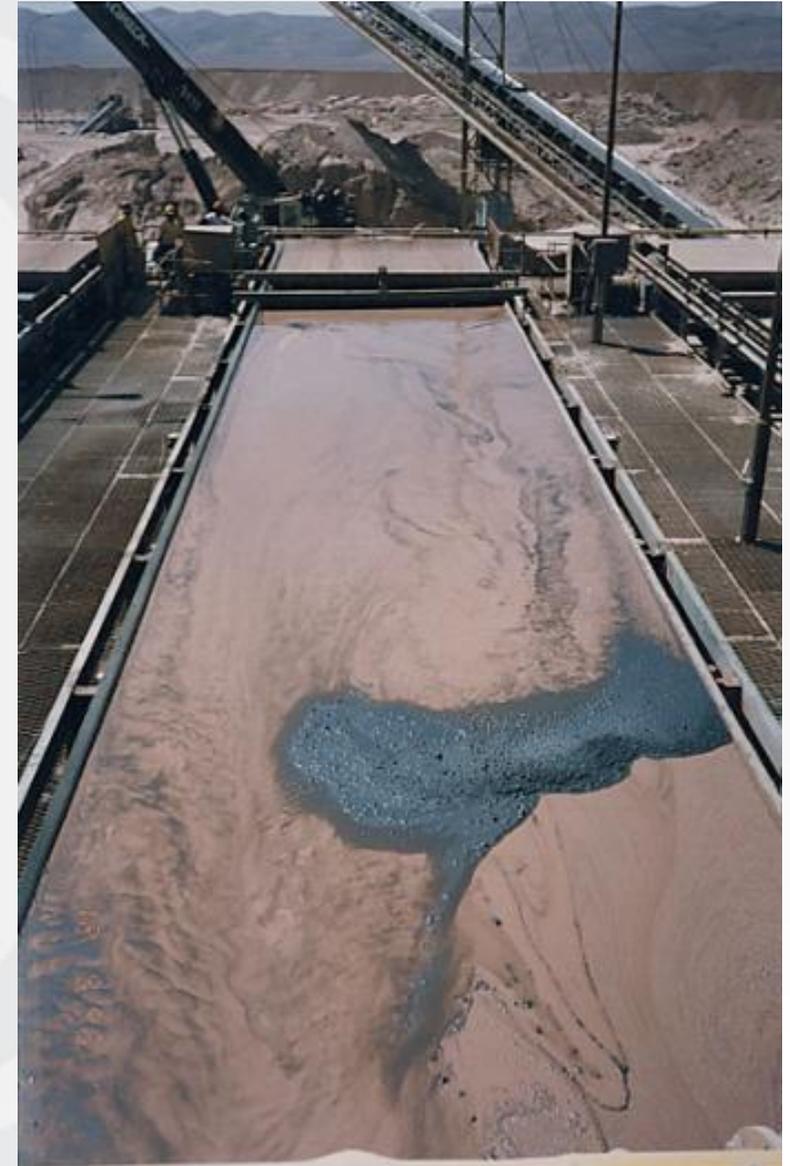
Horizontal Belt Vacuum Filters – Mantos Blancos, Chile

25,000 tpd to single stage cyclones

Cyclone underflow filtered, overflow thickened & stored separately

Filtered material on the belt.
Note the high water content of the feed material.

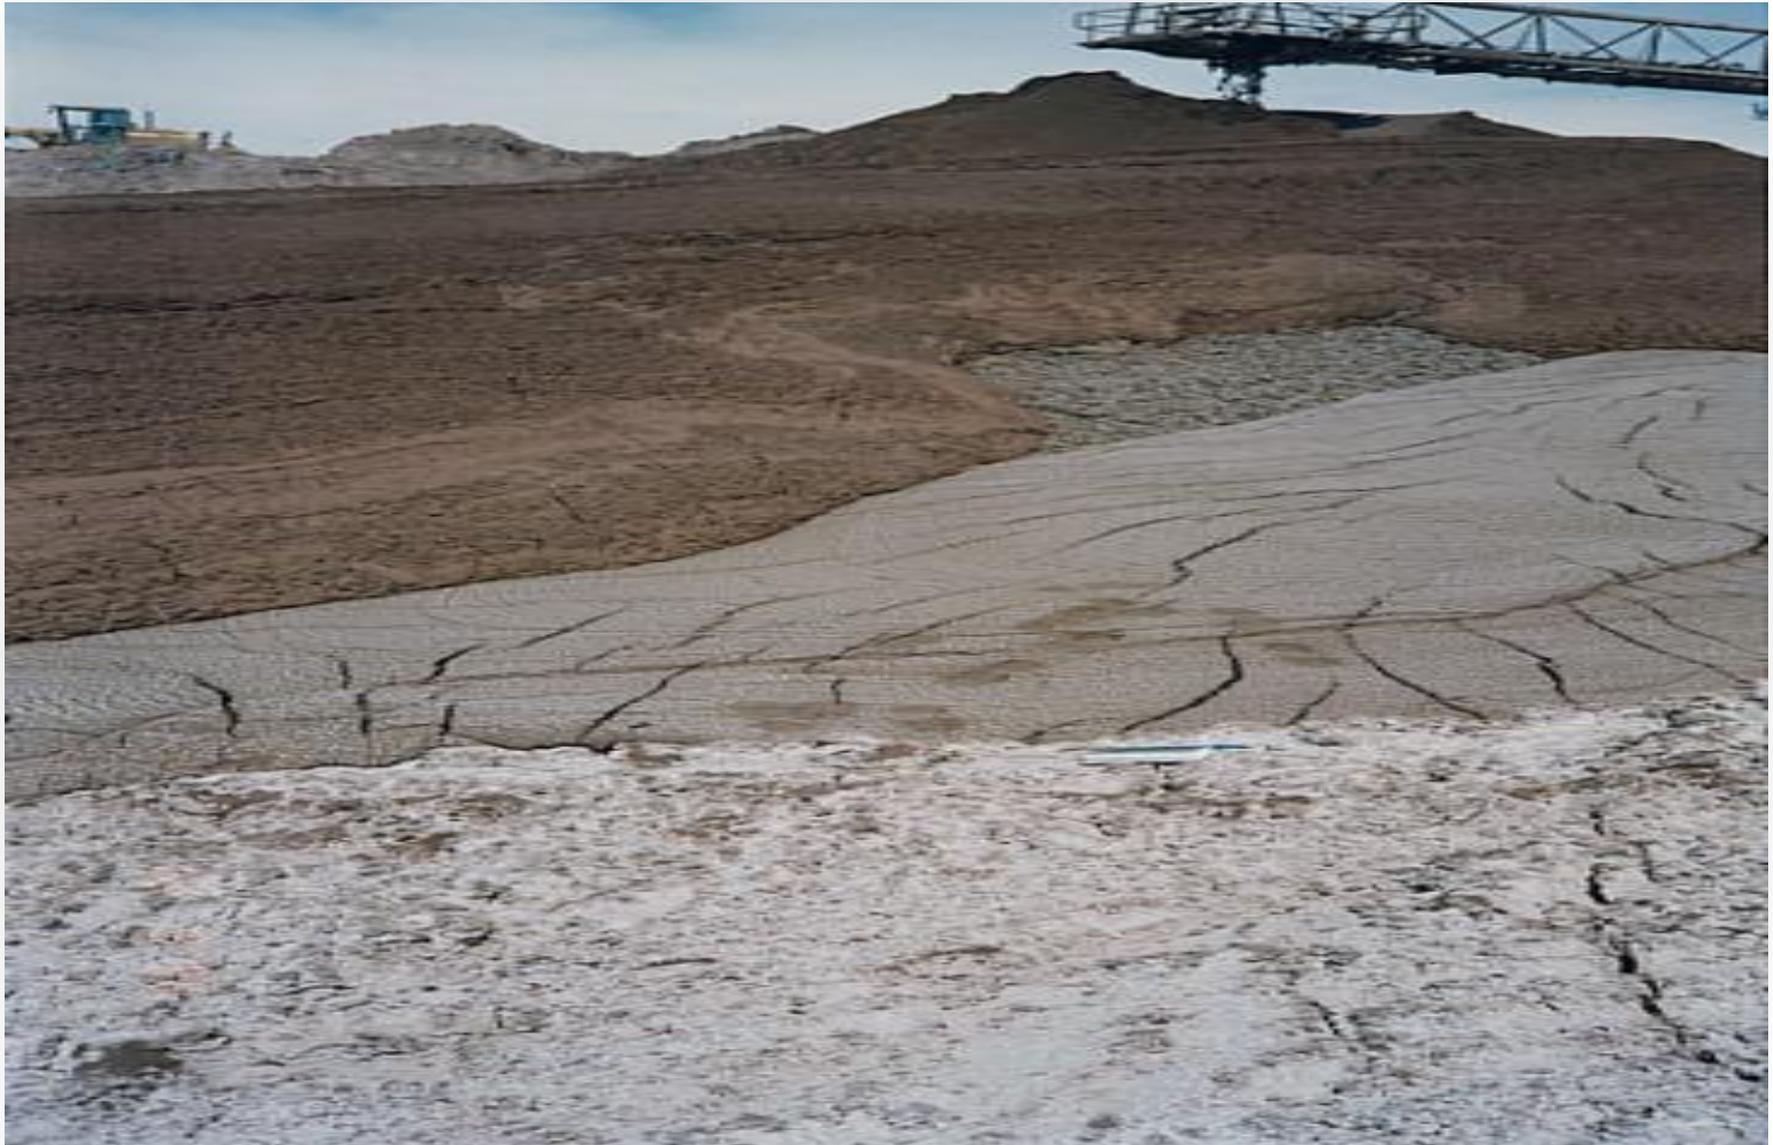
Cycloned/Dewatered Tailings Cone

Reduces fills by about 30%

Upstream stability is not an issue – in high seismic areas with high raises you may need to have a “slight” d/s slope.

Core zones, and even liners, can be placed vertically.

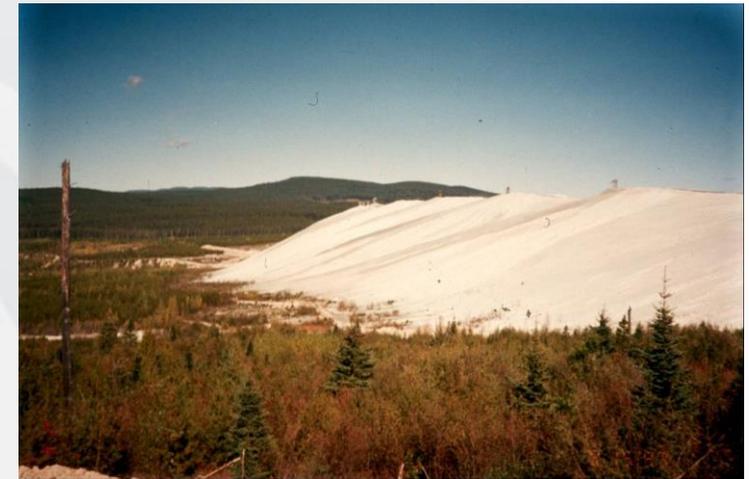
Sand Compaction

- ✓ Water kept away from dams to improve stability
- ✓ Till core to reduce seepage
- ✓ 3H:1V slopes for seismic stability and to facilitate reclamation

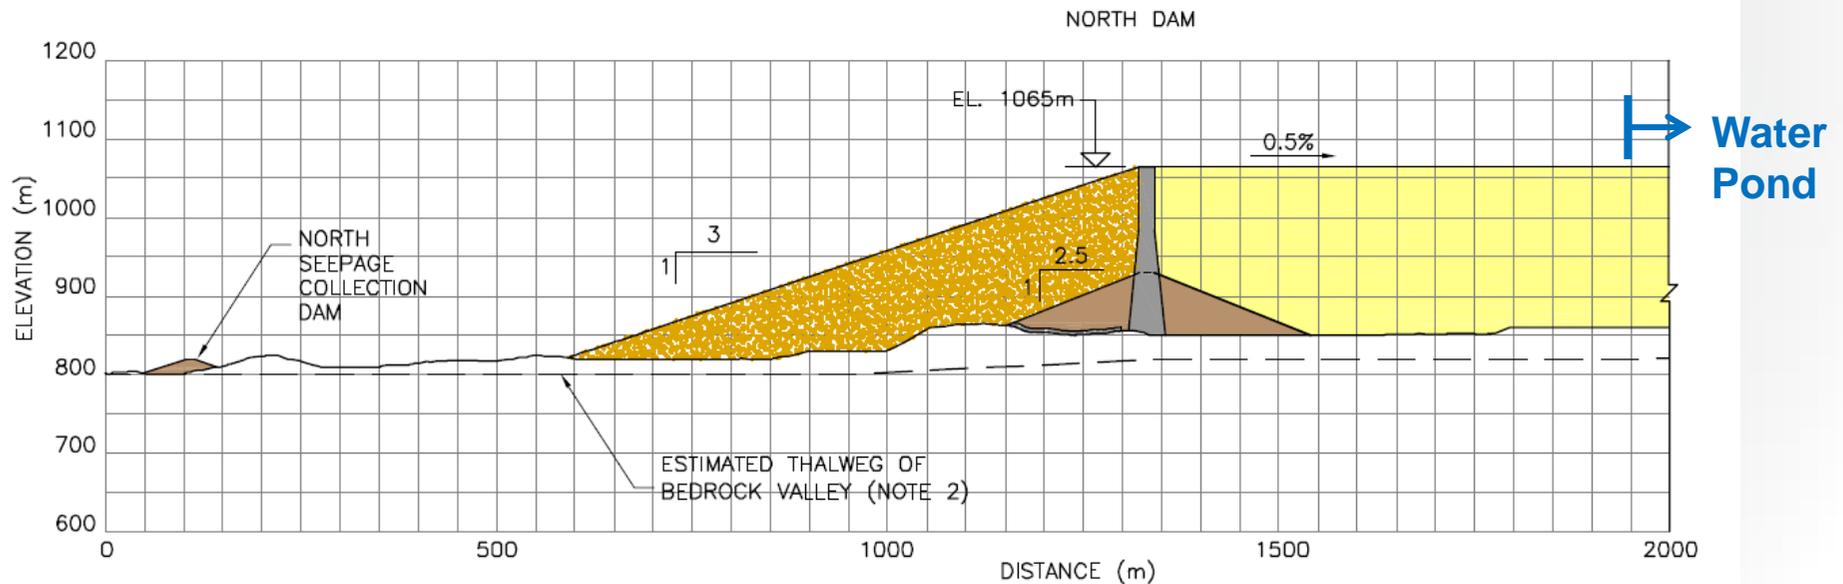
Gibraltar Cyclone Dam
