Tailings Overview

Harvey McLeod

October 2013

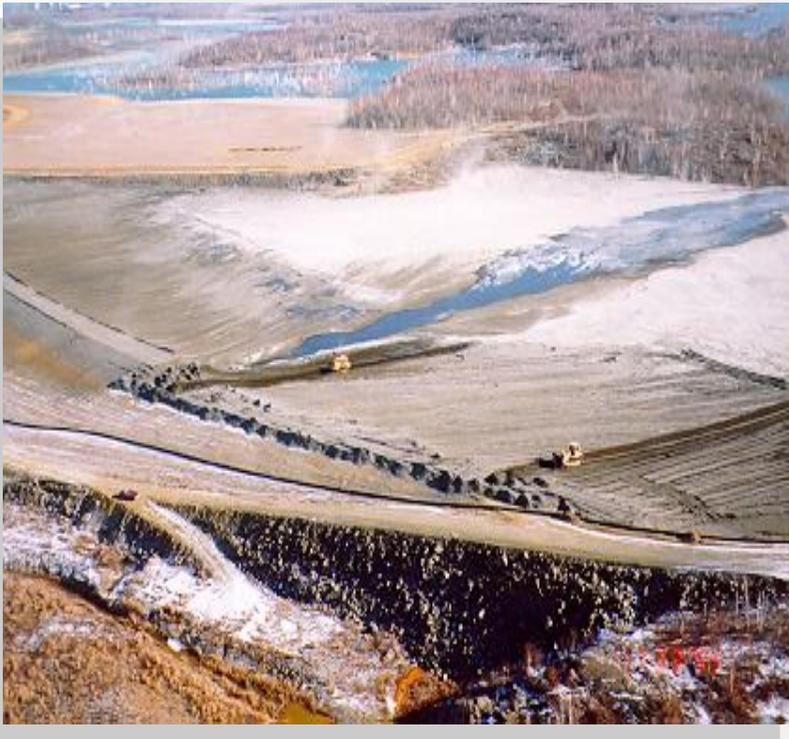
Upstream Construction : Vale Inco R4, Sudbury, Ontario

- Mine production - 36,000 tpd
- Height of Dams, 30 m, crest length, 5 km
- Total storage - 200 Mt
- EPCM
- Tailings management
- Slurry cut off
- Electrical/Mechanical Pipeline

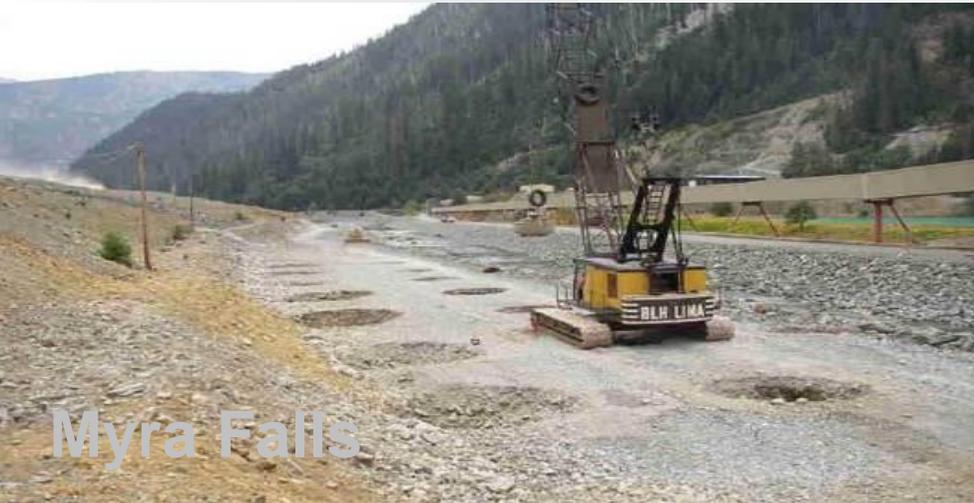
Depressurization well – artesian flow

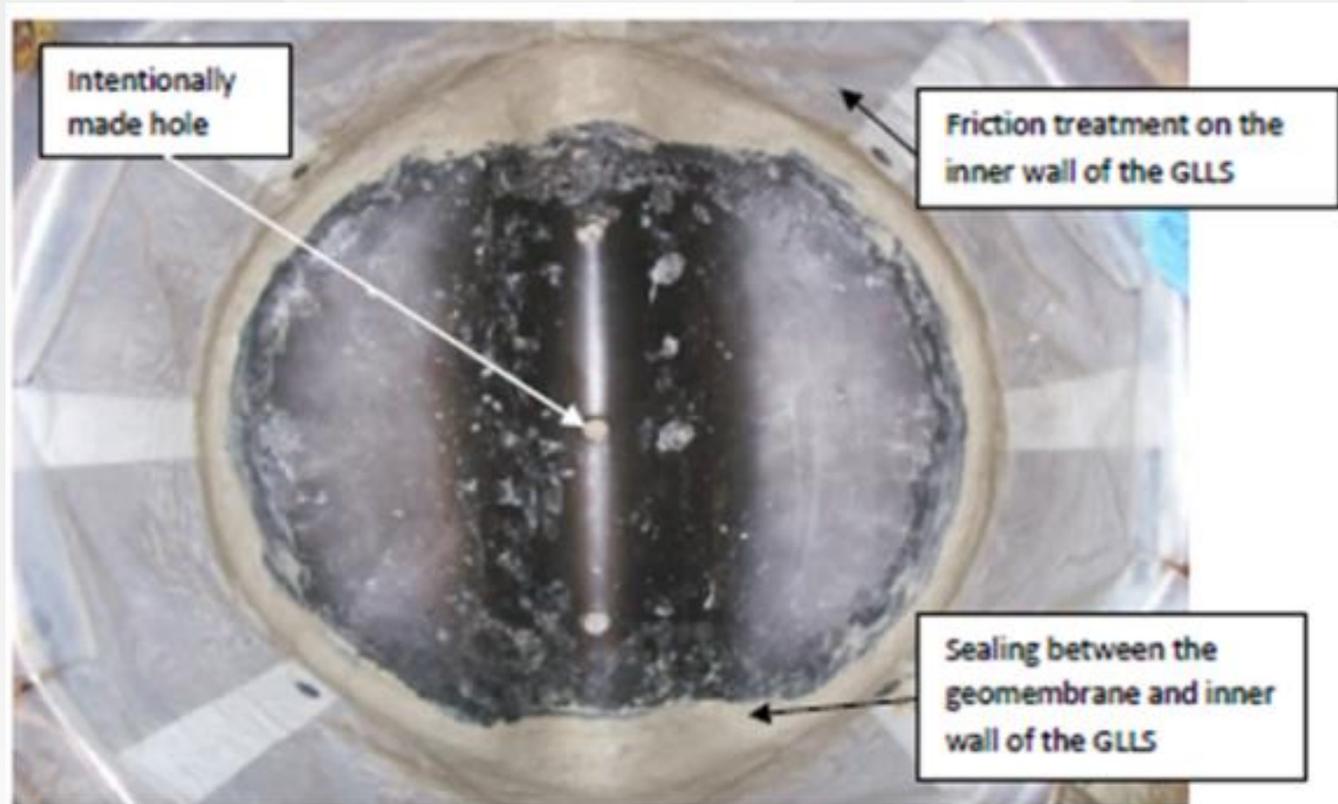
- Shunned for dams due to concerns with longevity.
- Tailings/geomembrane liners dramatically decrease potential seepage.
- Geotextile filter fabrics can be used for tailings dams with “dry” closure as gradients and piping risks do not exist over the long term.

1. A liner bedding layer is required
2. A liner protection layers is required to prevent ice damage
3. Drains are required over or between liners to reduce the head on the liner to reduce seepage
4. Geomembranes only last, maybe, a few hundred years.
5. QA/QC of liners is of “critical” importance.

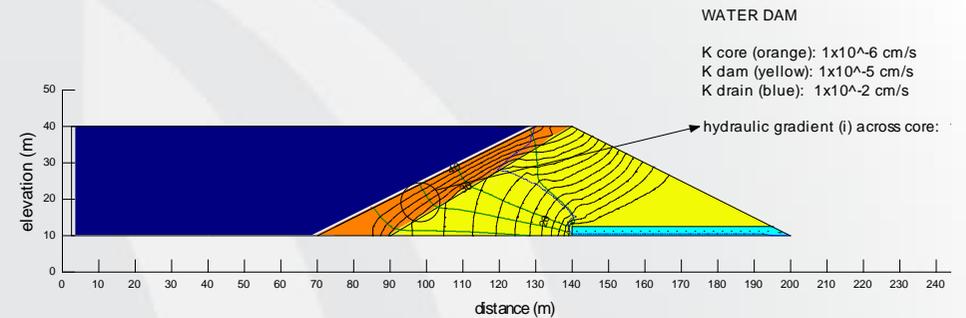
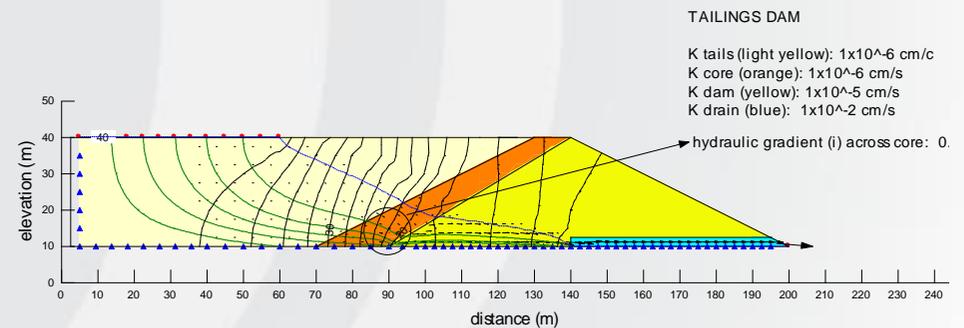
KCB avoids pervious zones on the upstream side of tailing dams

- Upstream pervious shell was designed for water dams for rapid drawdown condition (does not apply to tailing dams)
- Negates gradient reduction through the tailings.
- Increases risk of piping failure.
- Requires greater width of impervious zone to meet gradient requirements across the core of the dam

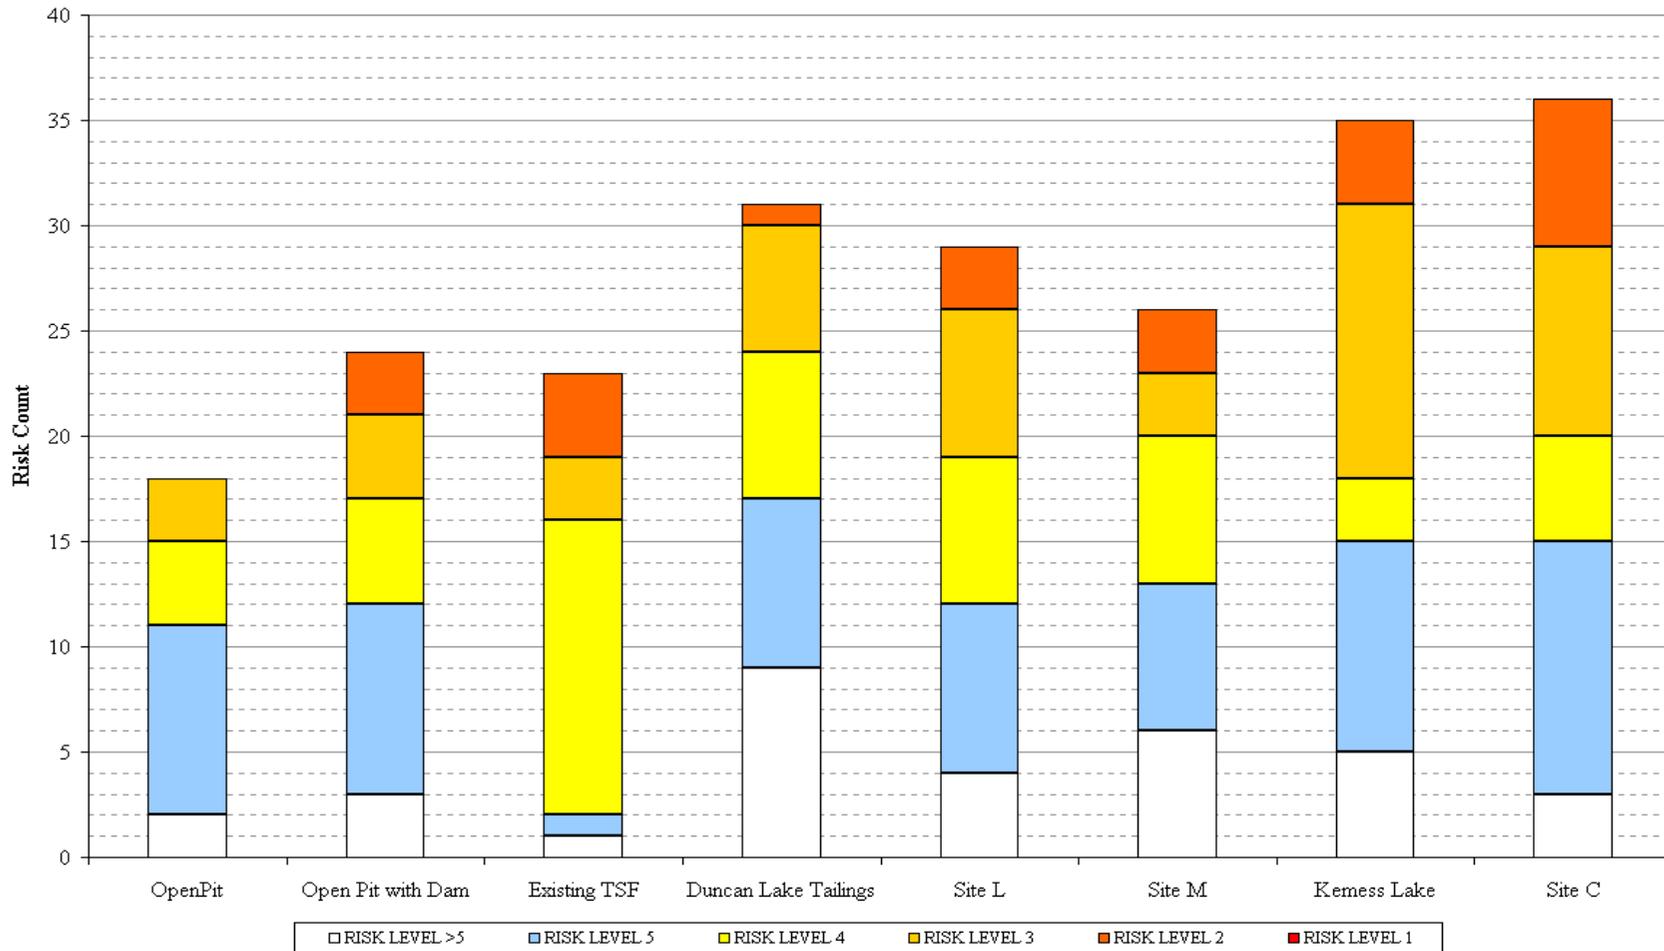
**Tailings Only Options:
Risk Level Breakdown**

All options have risks – understand and manage the risks

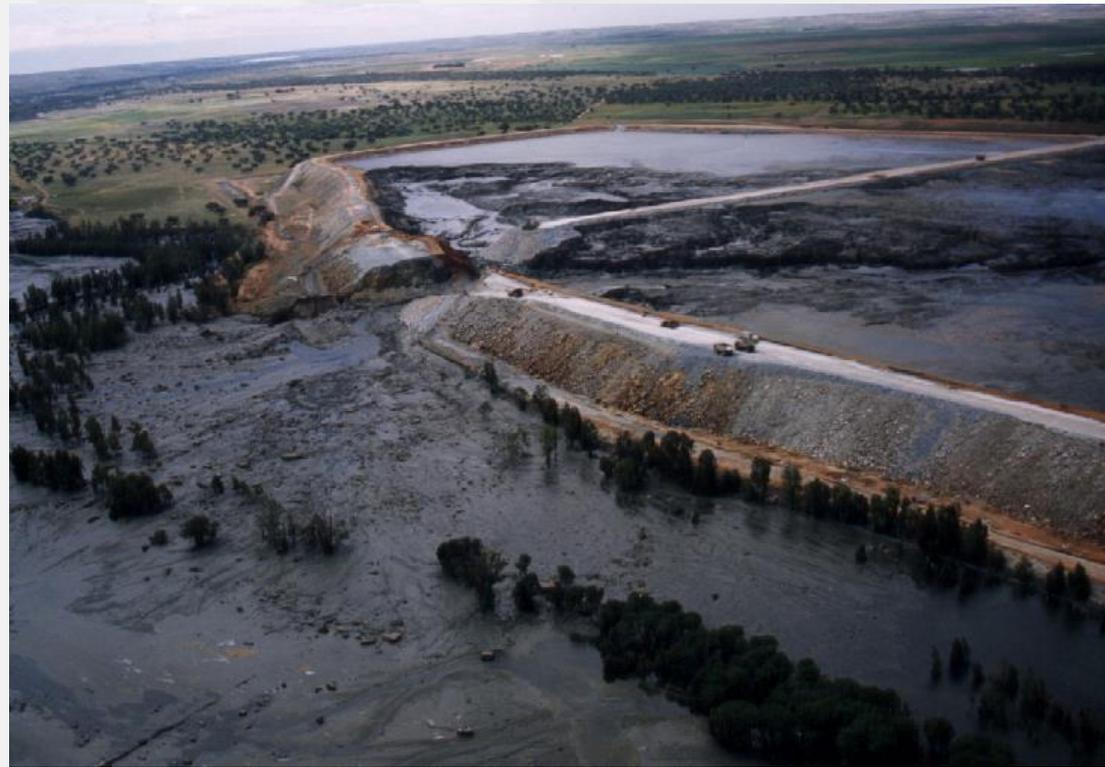
Tailing Dams

- Tailings solids can oxidize and/or leach metals.
- Tailings behave as a heavy fluid versus water.
- Dam Break ; slurry and water

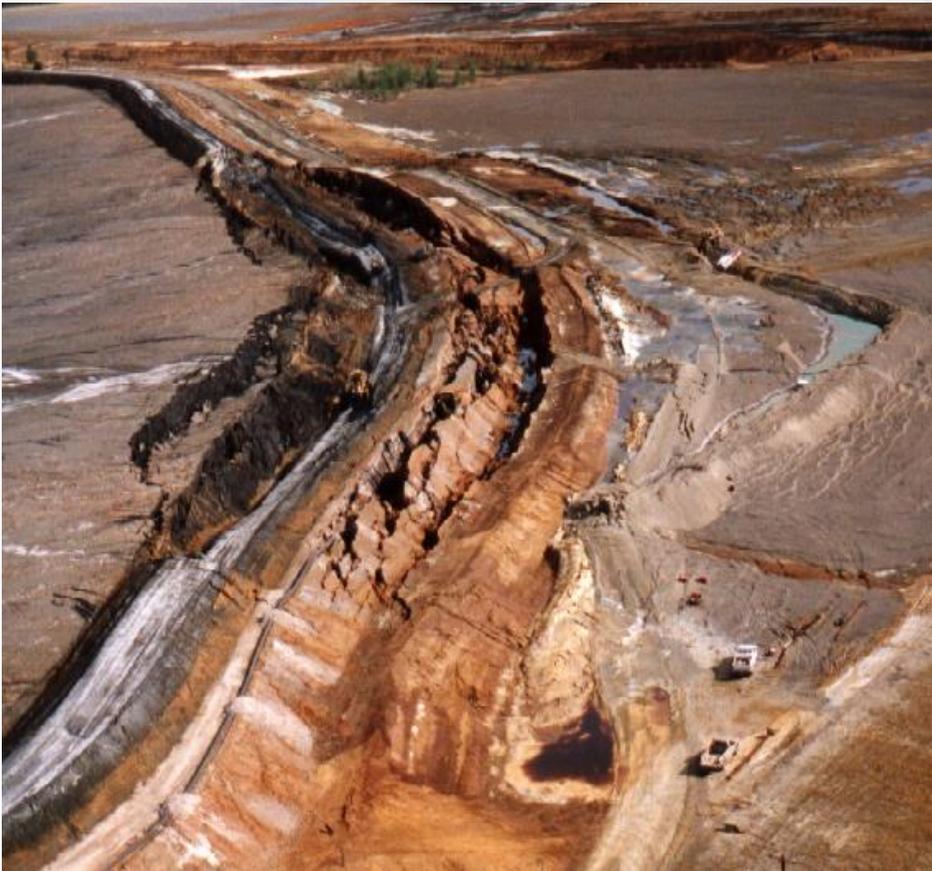
Static Liquefaction

(Sullivan Mine, B.C)

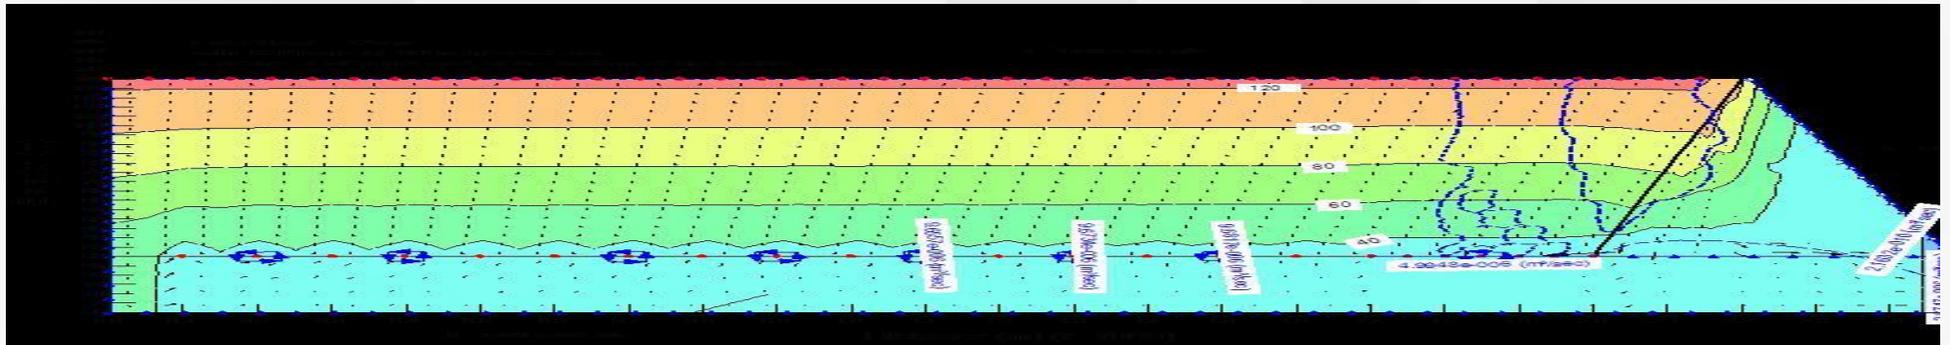
Components that increase risk without commensurate reduction in cost

Underdrain pipes that can be “clogged” by consolidated tailings and are at risk of movement or breakage leading to piping failures.

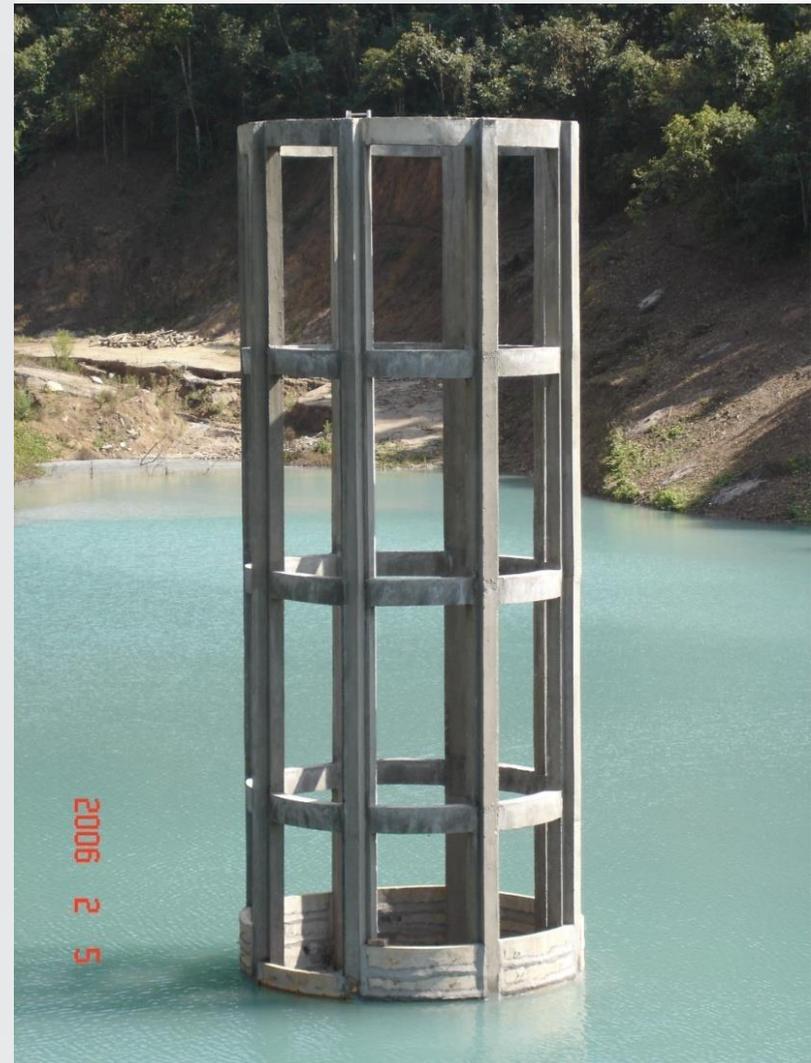
Reducing Water Management Risk

- Redundant spillways
- “Robust” storage of floods
- Closure “idiot” proofing of flood water release
- Avoid pipe inlets/decants

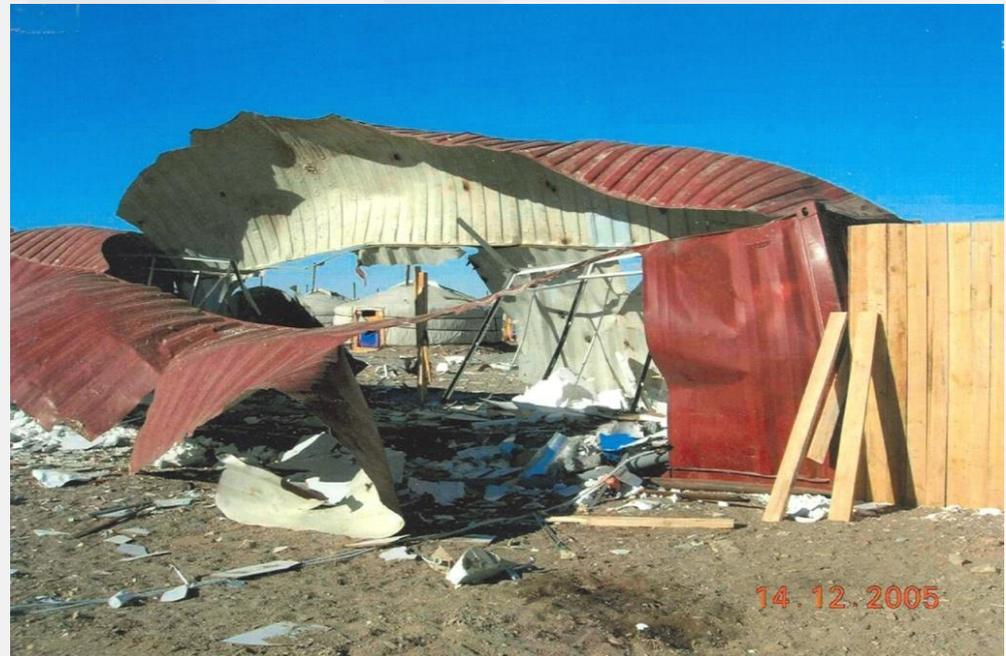
Tailings Risk – Assume the unexpected

Build in “robustness”

- Diversions will ice up or infill with sediment
- Spillways will get blocked with debris
- Operators will make mistakes
- QA/QC will vary

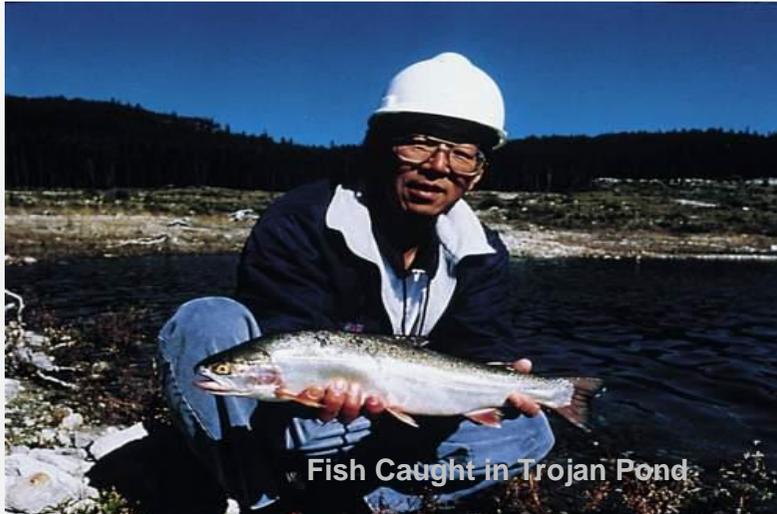
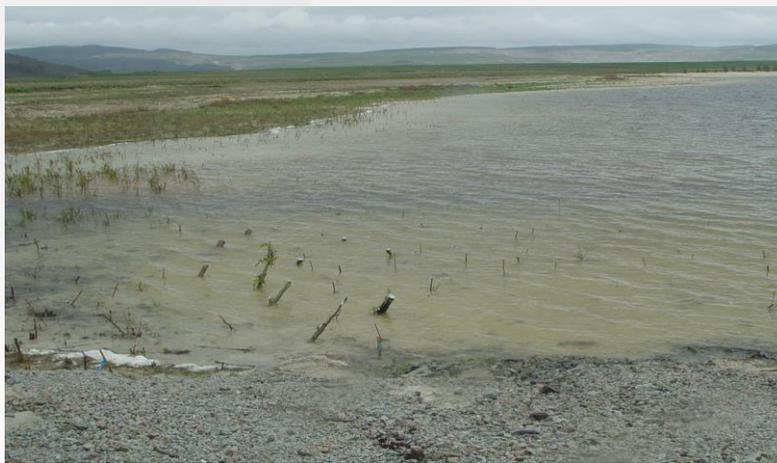
Trojan

Closure Plan-Lake Reclamation Porphyry Copper Experience – Highland Valley

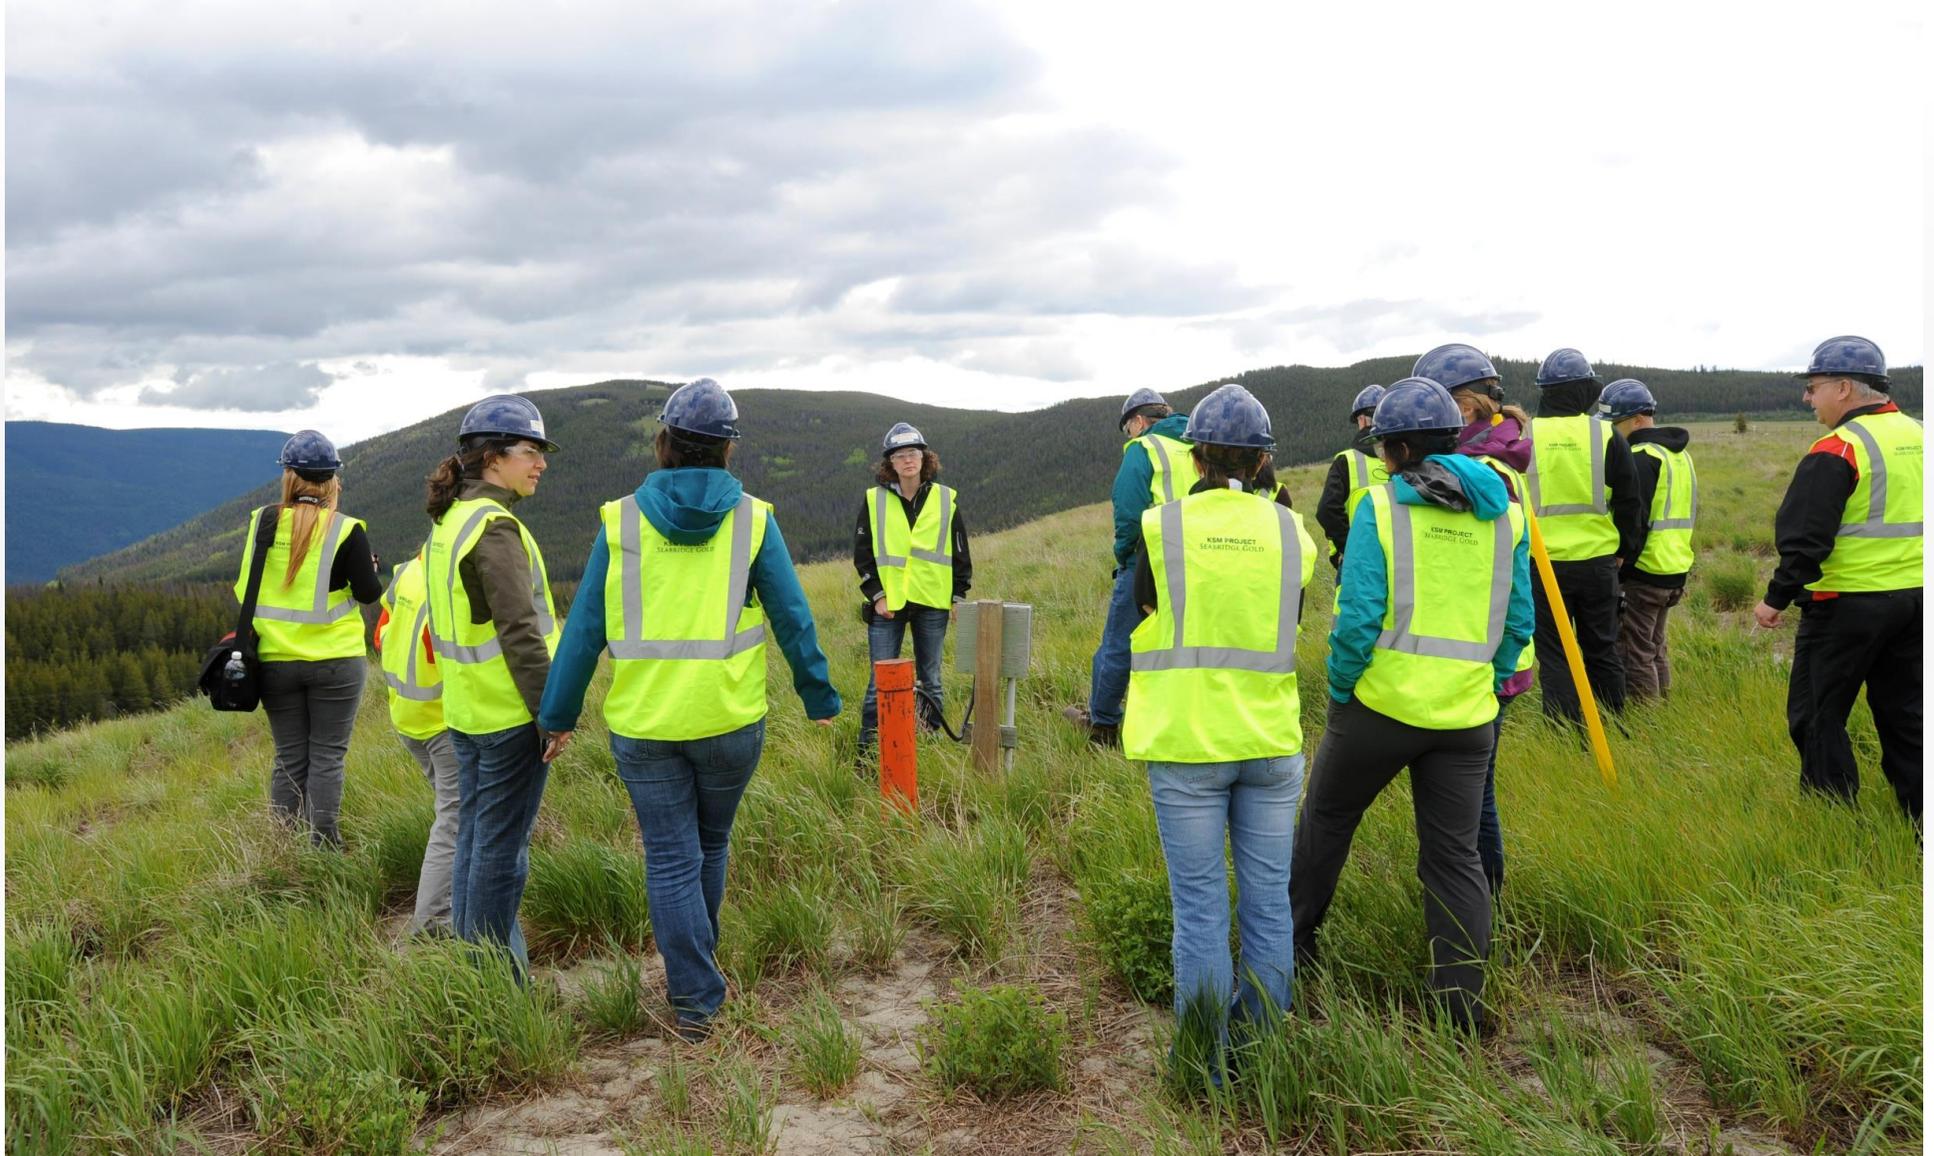
Re-vegetated Surface of Closed Brenda Cyclone Tailings Dam
